**CITY OF SAN MARCOS
ADA TRANSITION PLAN
SIGNALIZED INTERSECTION ASSESSMENT
AND COMPLIANCE REPORT**

Location ID: 0000000113
 North-South Cross Street: SESSOM DR
 East-West Cross Street: COMANCHE ST

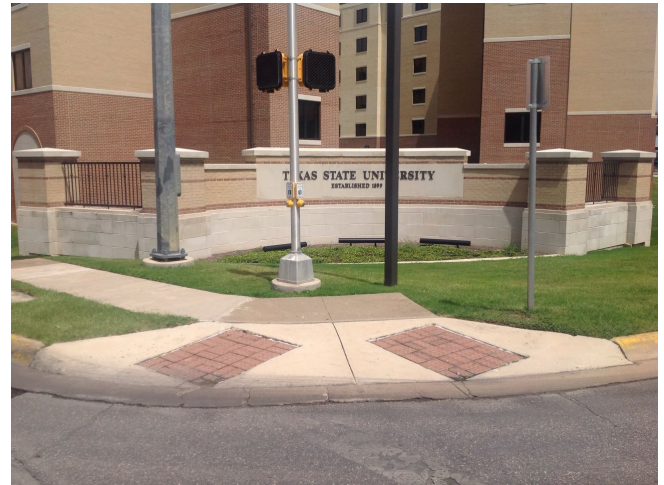
Signalized Intersection: YES
 Accessible Features: YES
 Pedestrian Features Accessible: YES

Ramp Elements	Curb ramp provided where an accessible route crosses a barrier:	YES
	Is the slope of the ramp 1:12 or less:	NO
	Transition from curb ramp slope to roadway free from abrupt changes, no greater than 1:20:	YES
	Ramp is at least 36" wide:	YES
	Ramp surface is stable, firm, and slip resistant:	YES
Flare	Flares (if present) are 1:10 or less measured along the curb line; or If landing at top of ramp is not provided flares are 1:12 or less:	NO
Detectable Warning Surface	Curb ramp is located such that it does not project into roadway or parking aisles:	N/A
	Detectable warning is present:	YES
	DWS maintains correct geometric controls; 0.9" diameter domes, 0.2" in height, spaced at 2.35" and visually contracts adjacent ramp surface:	YES
Special Ramps	Ramp maintains defined edges parallel to direction of pedestrian travel; maintains 4'x4' turning pad contained in crosswalk; flared sides 24" segment on each side of ramp within crosswalk lines:	N/A

Ramp is located so they will not be obstructed by parked vehicles:	N/A
	Ramp wholly contained within the crosswalk lines:	YES
	If island is present; Island maintains a cut through at street level or ramps on either side with landing between them:	N/A
