**CITY OF SAN MARCOS
ADA TRANSITION PLAN
SIGNALIZED INTERSECTION ASSESSMENT
AND COMPLIANCE REPORT**

Location ID: 000000121
 North-South Cross Street: HUTCHISON ST
 East-West Cross Street: MOORE ST

Location ID: 0000000121

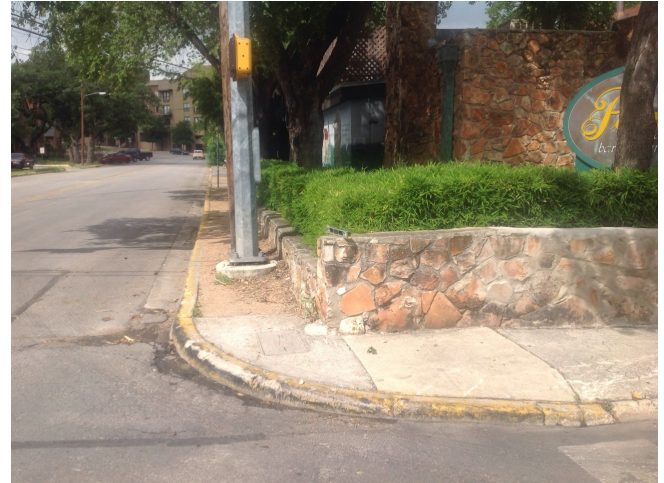
Signalized Intersection: YES
 Accessible Features: NO
 Pedestrian Features Accessible: NO

Ramp Elements	Curb ramp provided where an accessible route crosses a barrier:	NO
	Is the slope of the ramp 1:12 or less:	NO
	Transition from curb ramp slope to roadway free from abrupt changes, no greater than 1:20:	NO
	Ramp is at least 36" wide:	NO
	Ramp surface is stable, firm, and slip resistant:	NO
Flare	Flares (if present) are 1:10 or less measured along the curb line; or If landing at top of ramp is not provided flares are 1:12 or less:	NO
Detectable Warning Surface	Curb ramp is located such that it does not project into roadway or parking aisles:	N/A
	Detectable warning is present:	NO
	DWS maintains correct geometric controls; 0.9" diameter domes, 0.2" in height, spaced at 2.35" and visually contracts adjacent ramp surface:	NO
Special Ramps	Ramp maintains defined edges parallel to direction of pedestrian travel; maintains 4'x4' turning pad contained in crosswalk; flared sides 24" segment on each side of ramp within crosswalk lines:	N/A

Ramp is located so they will not be obstructed by parked vehicles:	N/A
	Ramp wholly contained within the crosswalk lines:	N/A
	If island is present; Island maintains a cut through at street level or ramps on either side with landing between them:	N/A
