**CITY OF SAN MARCOS
ADA TRANSITION PLAN
SIGNALIZED INTERSECTION ASSESSMENT
AND COMPLIANCE REPORT**

Location ID: 0000000141
 North-South Cross Street: SAN ANTONIO ST
 East-West Cross Street: LBJ ST

Location ID: 0000000141

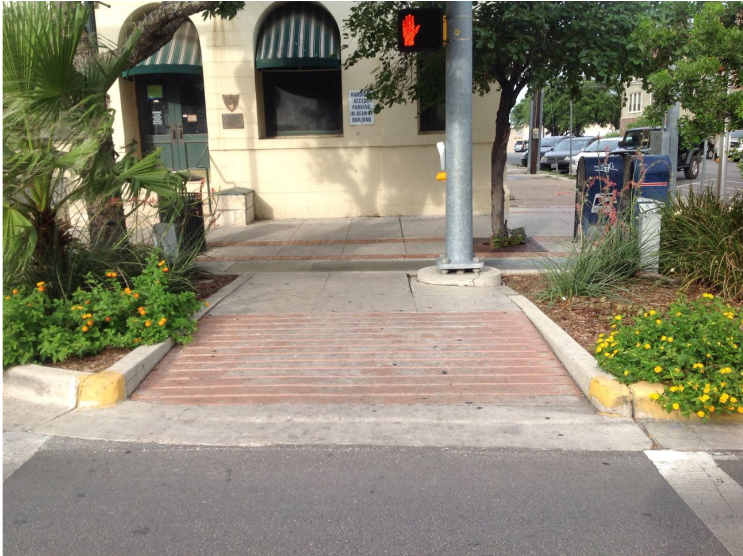
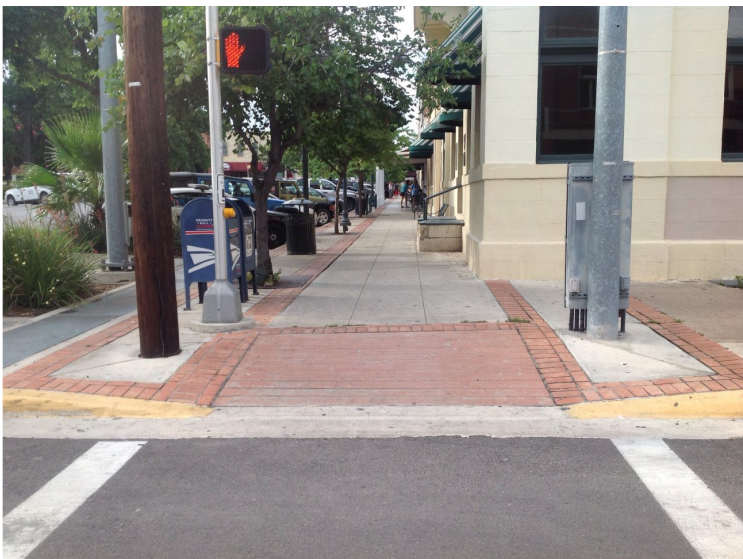
Location Photos

Ramp Elements	Curb ramp provided where an accessible route crosses a barrier:	YES
	Is the slope of the ramp 1:12 or less:	NO
	Transition from curb ramp slope to roadway free from abrupt changes, no greater than 1:20:	YES
	Ramp is at least 36" wide:	YES
	Ramp surface is stable, firm, and slip resistant:	YES
Flare	Flares (if present) are 1:10 or less measured along the curb line; or If landing at top of ramp is not provided flares are 1:12 or less:	N/A
Detectable Warning Surface	Curb ramp is located such that it does not project into roadway or parking aisles:	N/A
	Detectable warning is present:	NO
	DWS maintains correct geometric controls; 0.9" diameter domes, 0.2" in height, spaced at 2.35" and visually contrasts adjacent ramp surface:	NO
Special Ramps	Ramp maintains defined edges parallel to direction of pedestrian travel; maintains 4'x4' turning pad contained in crosswalk; flared sides 24" segment on each side of ramp within crosswalk lines:	N/A
