CITY OF SAN MARCOS ADA TRANSITION PLAN SIGNALIZED INTERSECTION ASSESSMENT AND COMPLIANCE REPORT

Location ID: 0000000173
 North-South Cross Street: IH 35 SBFR
 East-West Cross Street: AQUARENA SPRINGS DR

Location ID: 0000000173

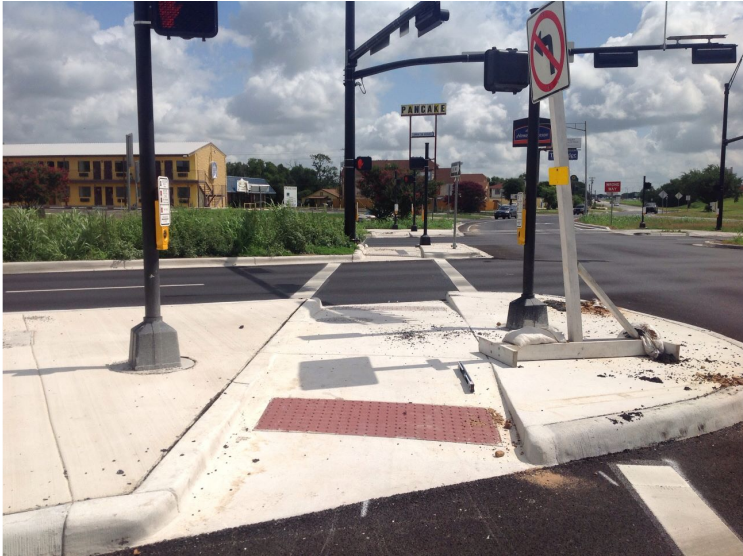
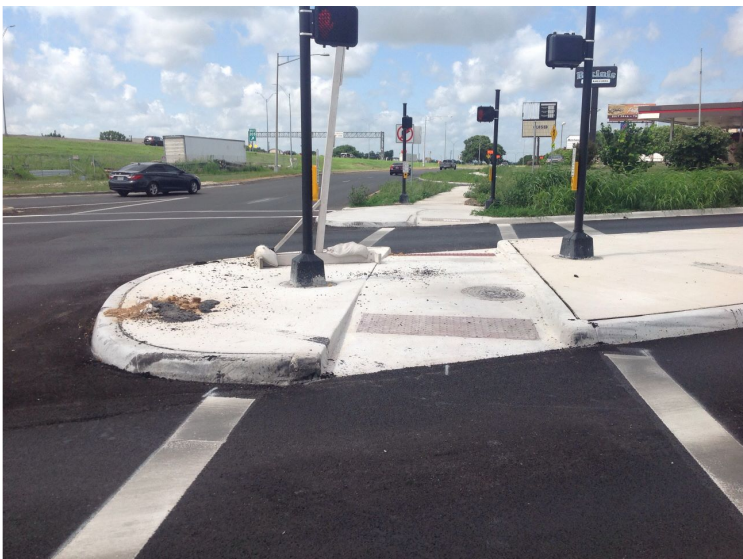
Location Photos

Ramp Elements	Curb ramp provided where an accessible route crosses a barrier:	YES
	Is the slope of the ramp 1:12 or less:	YES
	Transition from curb ramp slope to roadway free from abrupt changes, no greater than 1:20:	YES
	Ramp is at least 36" wide:	YES
	Ramp surface is stable, firm, and slip resistant:	YES
Flare	Flares (if present) are 1:10 or less measured along the curb line; or If landing at top of ramp is not provided flares are 1:12 or less:	NO
Detectable Warning Surface	Curb ramp is located such that it does not project into roadway or parking aisles:	N/A
	Detectable warning is present:	YES
	DWS maintains correct geometric controls; 0.9" diameter domes, 0.2" in height, spaced at 2.35" and visually contracts adjacent ramp surface:	YES
Special Ramps	Ramp maintains defined edges parallel to direction of pedestrian travel; maintains 4'x4' turning pad contained in crosswalk; flared sides 24" segment on each side of ramp within crosswalk lines:	N/A

Ramp is located so they will not be obstructed by parked vehicles:	N/A
	Ramp wholly contained within the crosswalk lines:	YES
	If island is present; Island maintains a cut through at street level or ramps on either side with landing between them:	YES
