**CITY OF SAN MARCOS  
ADA TRANSITION PLAN  
SIGNALIZED INTERSECTION ASSESSMENT  
AND COMPLIANCE REPORT**

Location ID: 0000000180  
 North-South Cross Street: IH 35 NBFR  
 East-West Cross Street: TX HWY 80

East-West Cross Street: TX HWY 80

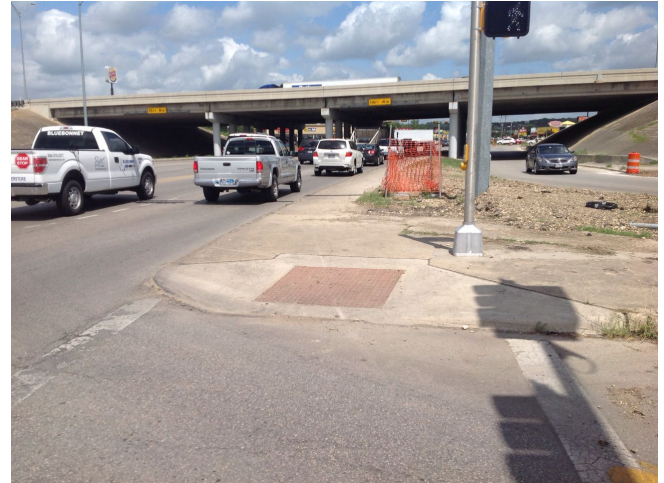
Signalized Intersection: YES  
 Accessible Features: YES  
 Pedestrian Features Accessible: YES

<b>Ramp Elements</b>	Curb ramp provided where an accessible route crosses a barrier:	YES
	Is the slope of the ramp 1:12 or less:	YES
	Transition from curb ramp slope to roadway free from abrupt changes, no greater than 1:20:	NO
	Ramp is at least 36" wide:	YES
	Ramp surface is stable, firm, and slip resistant:	YES
<b>Flare</b>	Flares (if present) are 1:10 or less measured along the curb line; or If landing at top of ramp is not provided flares are 1:12 or less:	YES
<b>Detectable Warning Surface</b>	Curb ramp is located such that it does not project into roadway or parking aisles:	N/A
	Detectable warning is present:	YES
	DWS maintains correct geometric controls; 0.9" diameter domes, 0.2" in height, spaced at 2.35" and visually contracts adjacent ramp surface:	YES
<b>Special Ramps</b>	Ramp maintains defined edges parallel to direction of pedestrian travel; maintains 4'x4' turning pad contained in crosswalk; flared sides 24" segment on each side of ramp within crosswalk lines:	N/A

Ramp is located so they will not be obstructed by parked vehicles:	N/A
	Ramp wholly contained within the crosswalk lines:	YES
	If island is present; Island maintains a cut through at street level or ramps on either side with landing between them:	N/A
