# CITY OF SAN MARCOS ADA TRANSITION PLAN SIGNALIZED INTERSECTION ASSESSMENT AND COMPLIANCE REPORT

Location ID: 0000000181  
 North-South Cross Street: IH 35 NBFR  
 East-West Cross Street: TX HWY 80

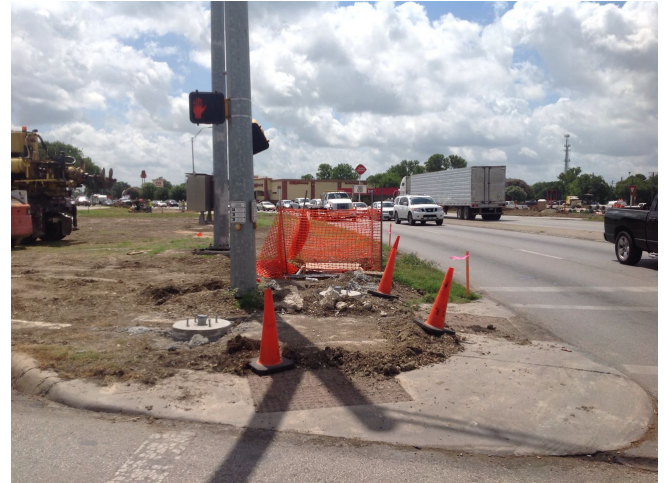
Signalized Intersection: YES  
 Accessible Features: YES  
 Pedestrian Features Accessible: YES

<b>Ramp Elements</b>	Curb ramp provided where an accessible route crosses a barrier:	YES
	Is the slope of the ramp 1:12 or less:	YES
	Transition from curb ramp slope to roadway free from abrupt changes, no greater than 1:20:	YES
	Ramp is at least 36" wide:	YES
	Ramp surface is stable, firm, and slip resistant:	YES
<b>Flare</b>	Flares (if present) are 1:10 or less measured along the curb line; or If landing at top of ramp is not provided flares are 1:12 or less:	YES
<b>Detectable Warning Surface</b>	Curb ramp is located such that it does not project into roadway or parking aisles:	N/A
	Detectable warning is present:	YES
	DWS maintains correct geometric controls; 0.9" diameter domes, 0.2" in height, spaced at 2.35" and visually contracts adjacent ramp surface:	YES
<b>Special Ramps</b>	Ramp maintains defined edges parallel to direction of pedestrian travel; maintains 4'x4' turning pad contained in crosswalk; flared sides 24" segment on each side of ramp within crosswalk lines:	N/A

Ramp is located so they will not be obstructed by parked vehicles:	N/A
	Ramp wholly contained within the crosswalk lines:	YES
	If island is present; Island maintains a cut through at street level or ramps on either side with landing between them:	YES
