CITY OF SAN MARCOS ADA TRANSITION PLAN SIGNALIZED INTERSECTION ASSESSMENT AND COMPLIANCE REPORT

Location ID: 0000000189
 North-South Cross Street: LONG ST
 East-West Cross Street: TX HWY 80

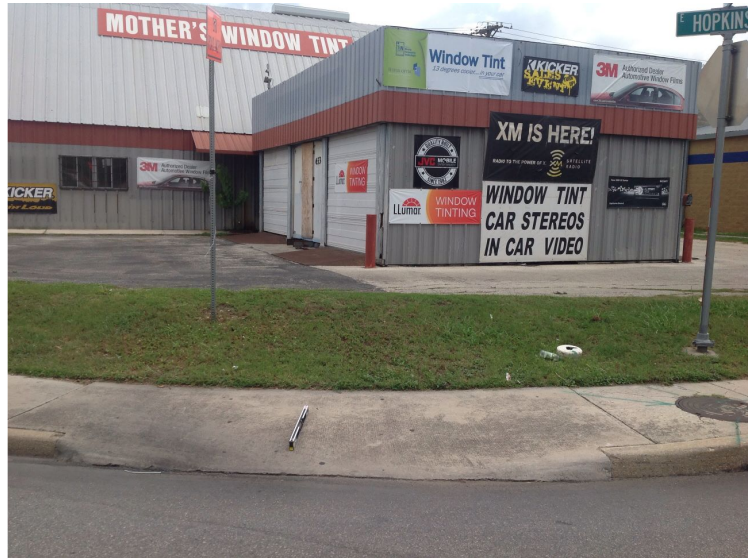
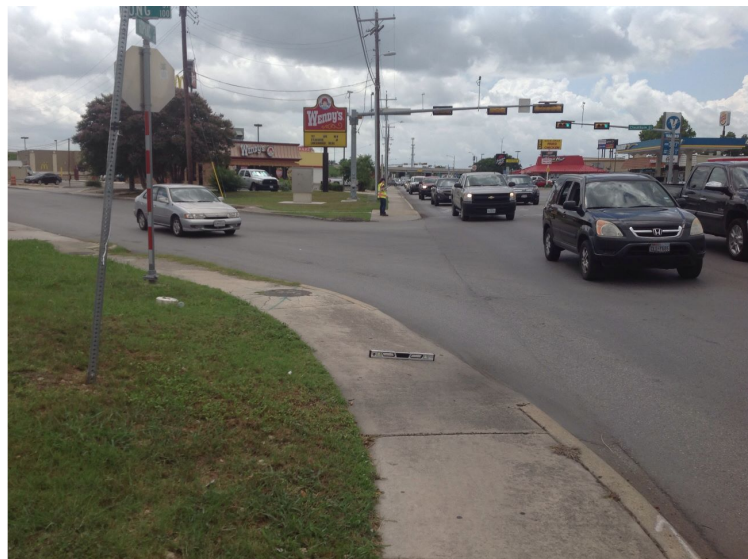
Location Photos

Ramp Elements	Curb ramp provided where an accessible route crosses a barrier:	YES
	Is the slope of the ramp 1:12 or less:	NO
	Transition from curb ramp slope to roadway free from abrupt changes, no greater than 1:20:	NO
	Ramp is at least 36" wide:	YES
	Ramp surface is stable, firm, and slip resistant:	YES
Flare	Flares (if present) are 1:10 or less measured along the curb line; or If landing at top of ramp is not provided flares are 1:12 or less:	NO
Detectable Warning Surface	Curb ramp is located such that it does not project into roadway or parking aisles:	N/A
	Detectable warning is present:	NO
	DWS maintains correct geometric controls; 0.9" diameter domes, 0.2" in height, spaced at 2.35" and visually contracts adjacent ramp surface:	NO
Special Ramps	Ramp maintains defined edges parallel to direction of pedestrian travel; maintains 4'x4' turning pad contained in crosswalk; flared sides 24" segment on each side of ramp within crosswalk lines:	N/A
