CITY OF SAN MARCOS ADA TRANSITION PLAN SIGNALIZED INTERSECTION ASSESSMENT AND COMPLIANCE REPORT

Location ID: 000000228
 North-South Cross Street: HUNTER RD
 East-West Cross Street: WONDERWORLD DR

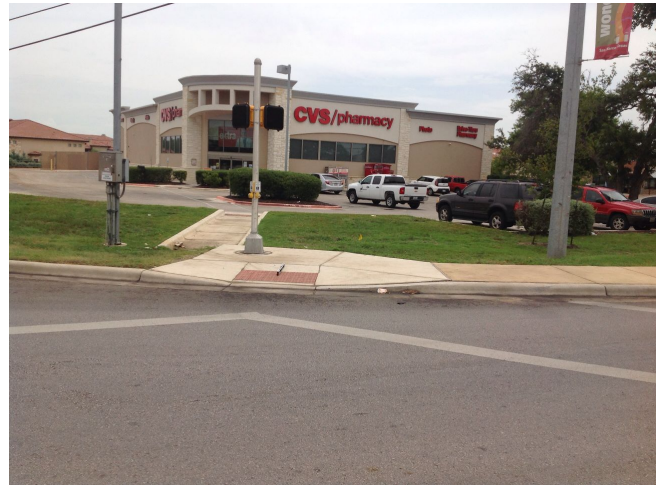
Signalized Intersection: YES
 Accessible Features: YES
 Pedestrian Features Accessible: YES

Ramp Elements	Curb ramp provided where an accessible route crosses a barrier:	YES
	Is the slope of the ramp 1:12 or less:	YES
	Transition from curb ramp slope to roadway free from abrupt changes, no greater than 1:20:	YES
	Ramp is at least 36" wide:	YES
	Ramp surface is stable, firm, and slip resistant:	
Flare	Flares (if present) are 1:10 or less measured along the curb line; or If landing at top of ramp is not provided flares are 1:12 or less:	YES
Detectable Warning Surface	Curb ramp is located such that it does not project into roadway or parking aisles:	N/A
	Detectable warning is present:	YES
	DWS maintains correct geometric controls; 0.9" diameter domes, 0.2" in height, spaced at 2.35" and visually contracts adjacent ramp surface:	YES
Special Ramps	Ramp maintains defined edges parallel to direction of pedestrian travel; maintains 4'x4' turning pad contained in crosswalk; flared sides 24" segment on each side of ramp within crosswalk lines:	YES

Ramp is located so they will not be obstructed by parked vehicles:	N/A
	Ramp wholly contained within the crosswalk lines:	YES
	If island is present; Island maintains a cut through at street level or ramps on either side with landing between them:	N/A
