CITY OF SAN MARCOS ADA TRANSITION PLAN SIGNALIZED INTERSECTION ASSESSMENT AND COMPLIANCE REPORT

Location ID: 0000000240
 North-South Cross Street: HOLLAND ST
 East-West Cross Street: RANCHROAD 12

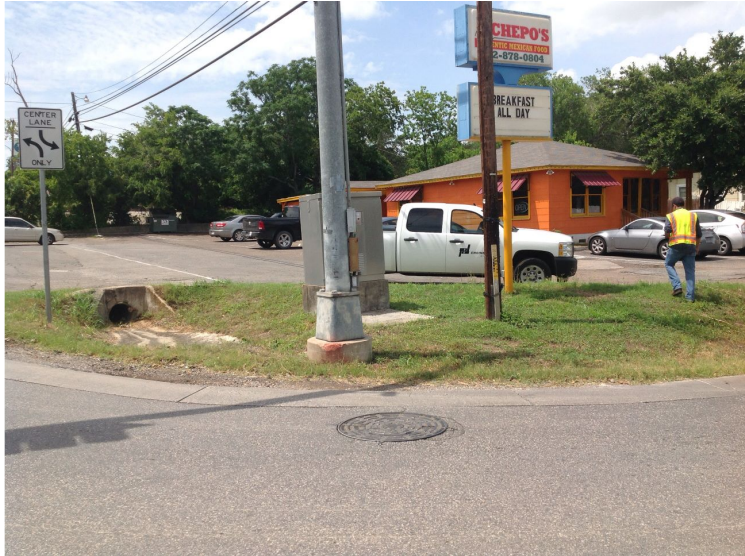
Location Photos

Ramp Elements	Curb ramp provided where an accessible route crosses a barrier:	NO
	Is the slope of the ramp 1:12 or less:	NO
	Transition from curb ramp slope to roadway free from abrupt changes, no greater than 1:20:	NO
	Ramp is at least 36" wide:	NO
	Ramp surface is stable, firm, and slip resistant:	NO
Flare	Flares (if present) are 1:10 or less measured along the curb line; or If landing at top of ramp is not provided flares are 1:12 or less:	NO
Detectable Warning Surface	Curb ramp is located such that it does not project into roadway or parking aisles:	N/A
	Detectable warning is present:	NO
	DWS maintains correct geometric controls; 0.9" diameter domes, 0.2" in height, spaced at 2.35" and visually contrasts adjacent ramp surface:	NO
Special Ramps	Ramp maintains defined edges parallel to direction of pedestrian travel; maintains 4'x4' turning pad contained in crosswalk; flared sides 24" segment on each side of ramp within crosswalk lines:	N/A
