**CITY OF SAN MARCOS  
ADA TRANSITION PLAN  
SIGNALIZED INTERSECTION ASSESSMENT  
AND COMPLIANCE REPORT**

Location ID: 0000000254  
 North-South Cross Street: UNIVERSITY DR  
 East-West Cross Street: LBJ

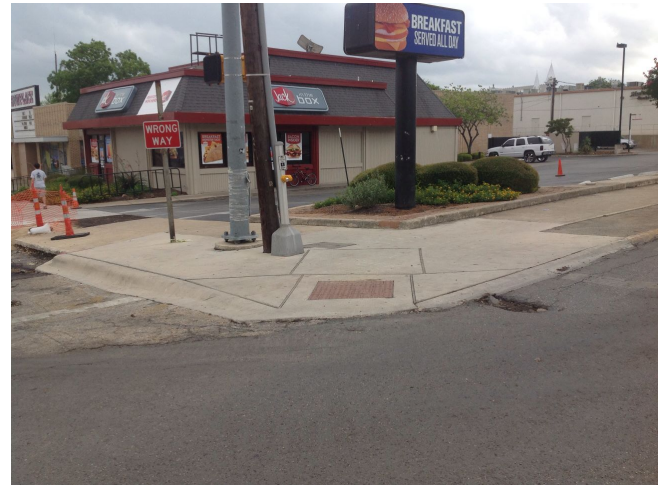
Signalized Intersection: YES  
 Accessible Features: YES  
 Pedestrian Features Accessible: YES

<b>Ramp Elements</b>	Curb ramp provided where an accessible route crosses a barrier:	YES
	Is the slope of the ramp 1:12 or less:	YES
	Transition from curb ramp slope to roadway free from abrupt changes, no greater than 1:20:	NO
	Ramp is at least 36" wide:	YES
	Ramp surface is stable, firm, and slip resistant:	YES
<b>Flare</b>	Flares (if present) are 1:10 or less measured along the curb line; or If landing at top of ramp is not provided flares are 1:12 or less:	NO
<b>Detectable Warning Surface</b>	Curb ramp is located such that it does not project into roadway or parking aisles:	N/A
	Detectable warning is present:	NO
	DWS maintains correct geometric controls; 0.9" diameter domes, 0.2" in height, spaced at 2.35" and visually contracts adjacent ramp surface:	YES
<b>Special Ramps</b>	Ramp maintains defined edges parallel to direction of pedestrian travel; maintains 4'x4' turning pad contained in crosswalk; flared sides 24" segment on each side of ramp within crosswalk lines:	NO

Ramp is located so they will not be obstructed by parked vehicles:	N/A
	Ramp wholly contained within the crosswalk lines:	YES
	If island is present; Island maintains a cut through at street level or ramps on either side with landing between them:	N/A
