**CITY OF SAN MARCOS  
ADA TRANSITION PLAN  
SIGNALIZED INTERSECTION ASSESSMENT  
AND COMPLIANCE REPORT**

Location ID: 0000000259  
 North-South Cross Street: HOPKINS ST  
 East-West Cross Street: EDWARD GARY

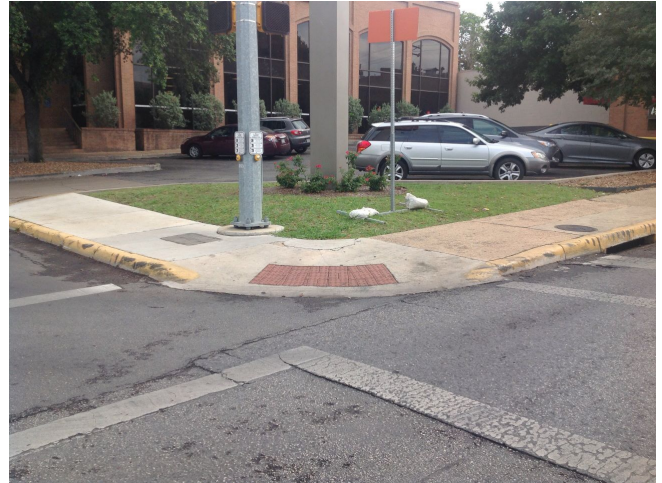
<b>Ramp Elements</b>	Curb ramp provided where an accessible route crosses a barrier:	YES
	Is the slope of the ramp 1:12 or less:	NO
	Transition from curb ramp slope to roadway free from abrupt changes, no greater than 1:20:	YES
	Ramp is at least 36" wide:	YES
	Ramp surface is stable, firm, and slip resistant:	YES
<b>Flare</b>	Flares (if present) are 1:10 or less measured along the curb line; or If landing at top of ramp is not provided flares are 1:12 or less:	NO
<b>Detectable Warning Surface</b>	Curb ramp is located such that it does not project into roadway or parking aisles:	N/A
	Detectable warning is present:	NO
	DWS maintains correct geometric controls; 0.9" diameter domes, 0.2" in height, spaced at 2.35" and visually contracts adjacent ramp surface:	YES
<b>Special Ramps</b>	Ramp maintains defined edges parallel to direction of pedestrian travel; maintains 4'x4' turning pad contained in crosswalk; flared sides 24" segment on each side of ramp within crosswalk lines:	YES

Ramp is located so they will not be obstructed by parked vehicles:	N/A
	Ramp wholly contained within the crosswalk lines:	YES
	If island is present; Island maintains a cut through at street level or ramps on either side with landing between them:	N/A
