**CITY OF SAN MARCOS  
ADA TRANSITION PLAN  
SIGNALIZED INTERSECTION ASSESSMENT  
AND COMPLIANCE REPORT**

Location ID: 0000000262  
 North-South Cross Street: HOPKINS ST  
 East-West Cross Street: C M ALLEN PKWY

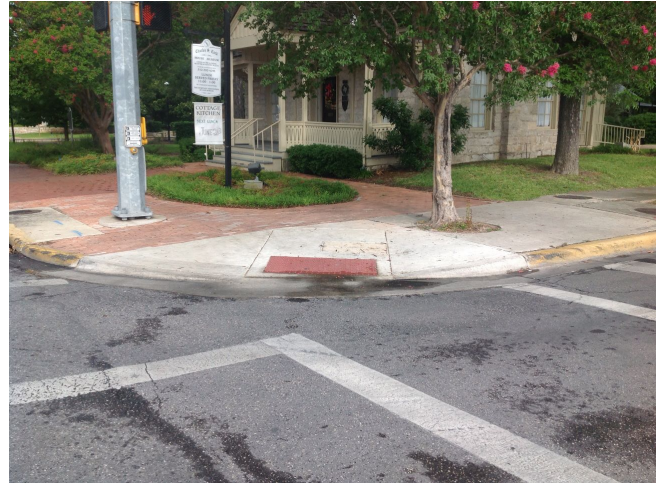
<b>Ramp Elements</b>	Curb ramp provided where an accessible route crosses a barrier:	YES
	Is the slope of the ramp 1:12 or less:	NO
	Transition from curb ramp slope to roadway free from abrupt changes, no greater than 1:20:	YES
	Ramp is at least 36" wide:	YES
	Ramp surface is stable, firm, and slip resistant:	YES
<b>Flare</b>	Flares (if present) are 1:10 or less measured along the curb line; or If landing at top of ramp is not provided flares are 1:12 or less:	NO
<b>Detectable Warning Surface</b>	Curb ramp is located such that it does not project into roadway or parking aisles:	N/A
	Detectable warning is present:	YES
	DWS maintains correct geometric controls; 0.9" diameter domes, 0.2" in height, spaced at 2.35" and visually contracts adjacent ramp surface:	YES
<b>Special Ramps</b>	Ramp maintains defined edges parallel to direction of pedestrian travel; maintains 4'x4' turning pad contained in crosswalk; flared sides 24" segment on each side of ramp within crosswalk lines:	YES

Ramp is located so they will not be obstructed by parked vehicles:	YES
	Ramp wholly contained within the crosswalk lines:	YES
	If island is present; Island maintains a cut through at street level or ramps on either side with landing between them:	YES
