**CITY OF SAN MARCOS  
ADA TRANSITION PLAN  
SIGNALIZED INTERSECTION ASSESSMENT  
AND COMPLIANCE REPORT**

Location ID: 0000000291  
 North-South Cross Street: THORPE LN  
 East-West Cross Street: AQUARENA SPRINGS DR

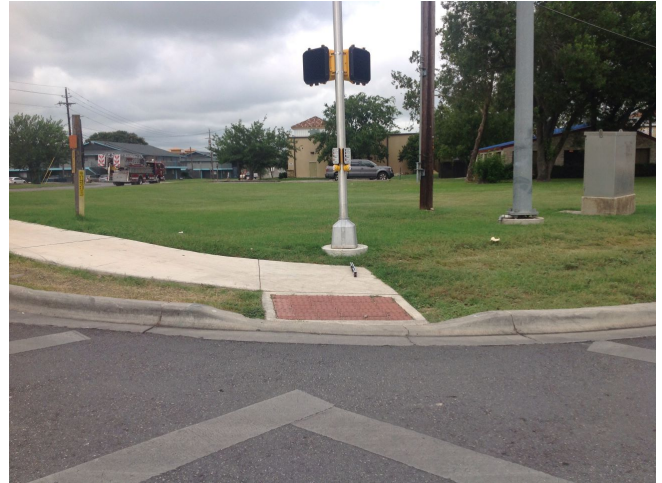
Signalized Intersection: YES  
 Accessible Features: YES  
 Pedestrian Features Accessible: NO

<b>Ramp Elements</b>	Curb ramp provided where an accessible route crosses a barrier:	YES
	Is the slope of the ramp 1:12 or less:	NO
	Transition from curb ramp slope to roadway free from abrupt changes, no greater than 1:20:	NO
	Ramp is at least 36" wide:	YES
	Ramp surface is stable, firm, and slip resistant:	YES
<b>Flare</b>	Flares (if present) are 1:10 or less measured along the curb line; or If landing at top of ramp is not provided flares are 1:12 or less:	NO
<b>Detectable Warning Surface</b>	Curb ramp is located such that it does not project into roadway or parking aisles:	N/A
	Detectable warning is present:	YES
	DWS maintains correct geometric controls; 0.9" diameter domes, 0.2" in height, spaced at 2.35" and visually contracts adjacent ramp surface:	YES
<b>Special Ramps</b>	Ramp maintains defined edges parallel to direction of pedestrian travel; maintains 4'x4' turning pad contained in crosswalk; flared sides 24" segment on each side of ramp within crosswalk lines:	YES

Ramp is located so they will not be obstructed by parked vehicles:	N/A
	Ramp wholly contained within the crosswalk lines:	YES
	If island is present; Island maintains a cut through at street level or ramps on either side with landing between them:	N/A
