**CITY OF SAN MARCOS  
ADA TRANSITION PLAN  
SIGNALIZED INTERSECTION ASSESSMENT  
AND COMPLIANCE REPORT**

Location ID: 0000000292  
 North-South Cross Street: POST RD  
 East-West Cross Street: AQUARENA SPRINGS DR

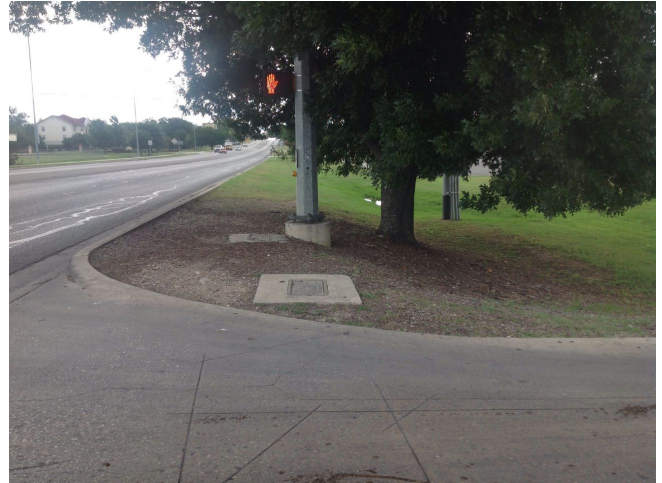
Signalized Intersection: YES  
 Accessible Features: YES  
 Pedestrian Features Accessible: NO

<b>Ramp Elements</b>	Curb ramp provided where an accessible route crosses a barrier:	NO
	Is the slope of the ramp 1:12 or less:	NO
	Transition from curb ramp slope to roadway free from abrupt changes, no greater than 1:20:	NO
	Ramp is at least 36" wide:	NO
	Ramp surface is stable, firm, and slip resistant:	NO
<b>Flare</b>	Flares (if present) are 1:10 or less measured along the curb line; or If landing at top of ramp is not provided flares are 1:12 or less:	NO
<b>Detectable Warning Surface</b>	Curb ramp is located such that it does not project into roadway or parking aisles:	N/A
	Detectable warning is present:	NO
	DWS maintains correct geometric controls; 0.9" diameter domes, 0.2" in height, spaced at 2.35" and visually contracts adjacent ramp surface:	NO
<b>Special Ramps</b>	Ramp maintains defined edges parallel to direction of pedestrian travel; maintains 4'x4' turning pad contained in crosswalk; flared sides 24" segment on each side of ramp within crosswalk lines:	N/A
