**CITY OF SAN MARCOS  
ADA TRANSITION PLAN  
SIGNALIZED INTERSECTION ASSESSMENT  
AND COMPLIANCE REPORT**

Location ID: 0000000298  
 North-South Cross Street: NBFR IH 35  
 East-West Cross Street: AQUARENA SPRINGS DR

Location ID: 0000000298

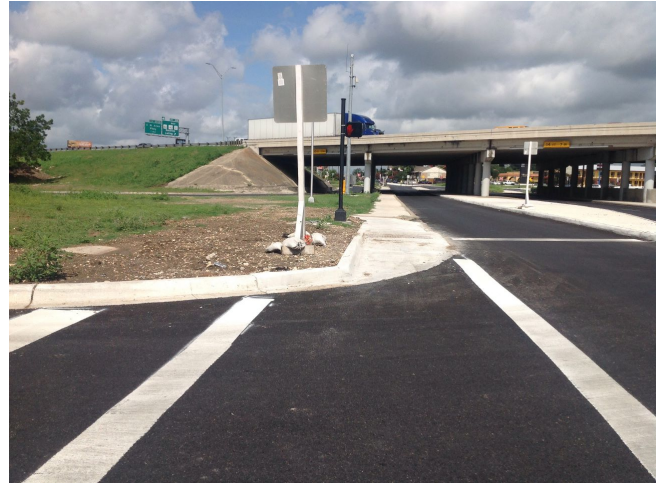
Signalized Intersection: YES  
 Accessible Features: YES  
 Pedestrian Features Accessible: YES

<b>Ramp Elements</b>	Curb ramp provided where an accessible route crosses a barrier:	YES
	Is the slope of the ramp 1:12 or less:	YES
	Transition from curb ramp slope to roadway free from abrupt changes, no greater than 1:20:	YES
	Ramp is at least 36" wide:	YES
	Ramp surface is stable, firm, and slip resistant:	YES
<b>Flare</b>	Flares (if present) are 1:10 or less measured along the curb line; or If landing at top of ramp is not provided flares are 1:12 or less:	N/A
<b>Detectable Warning Surface</b>	Curb ramp is located such that it does not project into roadway or parking aisles:	N/A
	Detectable warning is present:	YES
	DWS maintains correct geometric controls; 0.9" diameter domes, 0.2" in height, spaced at 2.35" and visually contracts adjacent ramp surface:	YES
<b>Special Ramps</b>	Ramp maintains defined edges parallel to direction of pedestrian travel; maintains 4'x4' turning pad contained in crosswalk; flared sides 24" segment on each side of ramp within crosswalk lines:	N/A

Ramp is located so they will not be obstructed by parked vehicles:	N/A
	Ramp wholly contained within the crosswalk lines:	YES
	If island is present; Island maintains a cut through at street level or ramps on either side with landing between them:	N/A
