**CITY OF SAN MARCOS
ADA TRANSITION PLAN
SIGNALIZED INTERSECTION ASSESSMENT
AND COMPLIANCE REPORT**

Location ID: 0000000300
 North-South Cross Street: NBFR IH 35
 East-West Cross Street: AQUARENA SPRINGS DR

Date of Evaluation: 6/27/2014
 Latitude: 29.893073 Longitude: -97.911381
<https://maps.google.com/maps?t=h&q=29.893073+-97.911381>

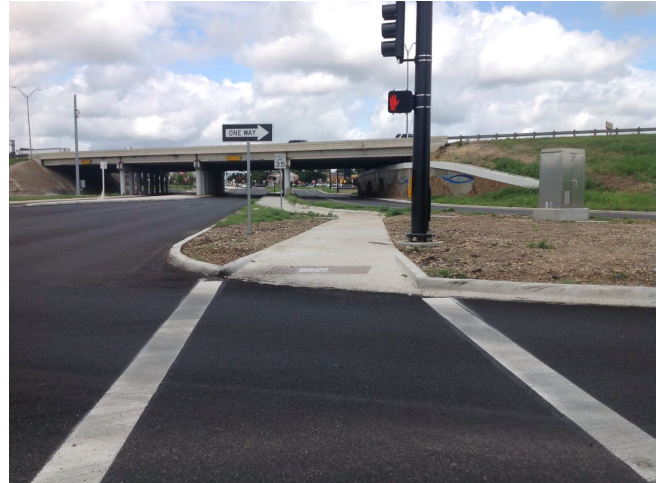
Signalized Intersection: YES
 Accessible Features: YES
 Pedestrian Features Accessible: YES

Ramp Elements	Curb ramp provided where an accessible route crosses a barrier:	YES
	Is the slope of the ramp 1:12 or less:	YES
	Transition from curb ramp slope to roadway free from abrupt changes, no greater than 1:20:	YES
	Ramp is at least 36" wide:	YES
	Ramp surface is stable, firm, and slip resistant:	YES
Flare	Flares (if present) are 1:10 or less measured along the curb line; or If landing at top of ramp is not provided flares are 1:12 or less:	N/A
Detectable Warning Surface	Curb ramp is located such that it does not project into roadway or parking aisles:	N/A
	Detectable warning is present:	NO
	DWS maintains correct geometric controls; 0.9" diameter domes, 0.2" in height, spaced at 2.35" and visually contrasts adjacent ramp surface:	YES
Special Ramps	Ramp maintains defined edges parallel to direction of pedestrian travel; maintains 4'x4' turning pad contained in crosswalk; flared sides 24" segment on each side of ramp within crosswalk lines:	N/A

Ramp is located so they will not be obstructed by parked vehicles:	N/A
	Ramp wholly contained within the crosswalk lines:	YES
	If island is present; Island maintains a cut through at street level or ramps on either side with landing between them:	N/A
