**CITY OF SAN MARCOS  
ADA TRANSITION PLAN  
SIGNALIZED INTERSECTION ASSESSMENT  
AND COMPLIANCE REPORT**

Location ID: 0000000301  
 North-South Cross Street: NBFR IH 35  
 East-West Cross Street: AQUARENA SPRINGS DR

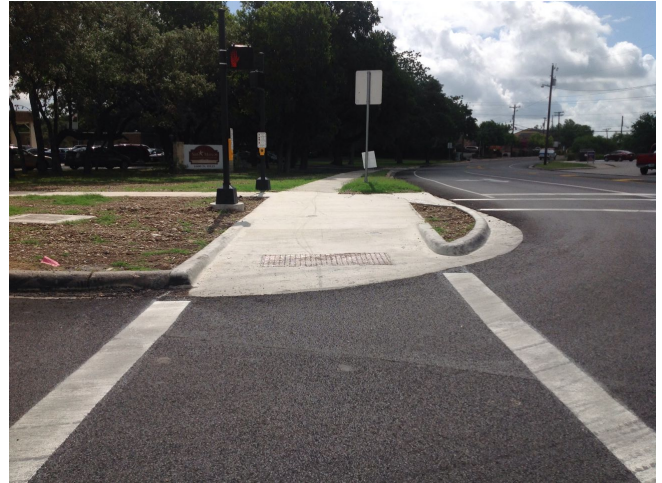
Signalized Intersection: YES  
 Accessible Features: YES  
 Pedestrian Features Accessible: YES

<b>Ramp Elements</b>	Curb ramp provided where an accessible route crosses a barrier:	YES
	Is the slope of the ramp 1:12 or less:	YES
	Transition from curb ramp slope to roadway free from abrupt changes, no greater than 1:20:	YES
	Ramp is at least 36" wide:	YES
	Ramp surface is stable, firm, and slip resistant:	YES
<b>Flare</b>	Flares (if present) are 1:10 or less measured along the curb line; or If landing at top of ramp is not provided flares are 1:12 or less:	N/A
<b>Detectable Warning Surface</b>	Curb ramp is located such that it does not project into roadway or parking aisles:	N/A
	Detectable warning is present:	NO
	DWS maintains correct geometric controls; 0.9" diameter domes, 0.2" in height, spaced at 2.35" and visually contracts adjacent ramp surface:	YES
<b>Special Ramps</b>	Ramp maintains defined edges parallel to direction of pedestrian travel; maintains 4'x4' turning pad contained in crosswalk; flared sides 24" segment on each side of ramp within crosswalk lines:	N/A

Ramp is located so they will not be obstructed by parked vehicles:	N/A
	Ramp wholly contained within the crosswalk lines:	YES
	If island is present; Island maintains a cut through at street level or ramps on either side with landing between them:	N/A
