CITY OF SAN MARCOS ADA TRANSITION PLAN SIGNALIZED INTERSECTION ASSESSMENT AND COMPLIANCE REPORT

Location ID: 0000000308
 North-South Cross Street: SBFR IH 35
 East-West Cross Street: TX HWY 80

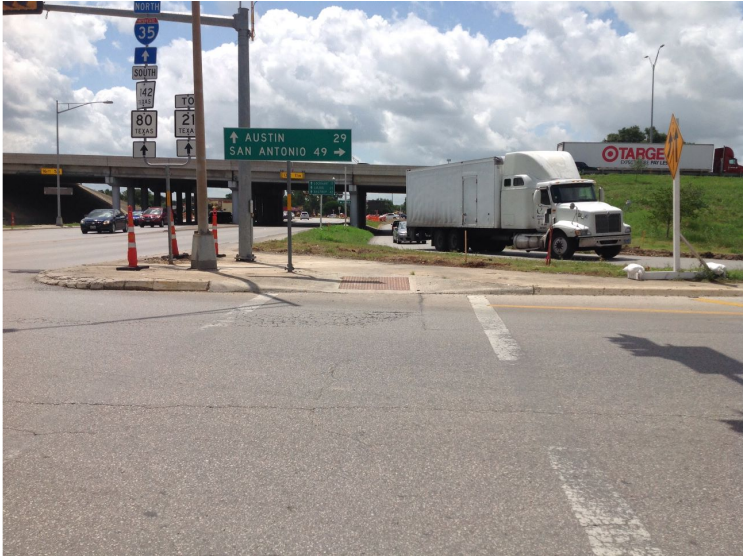
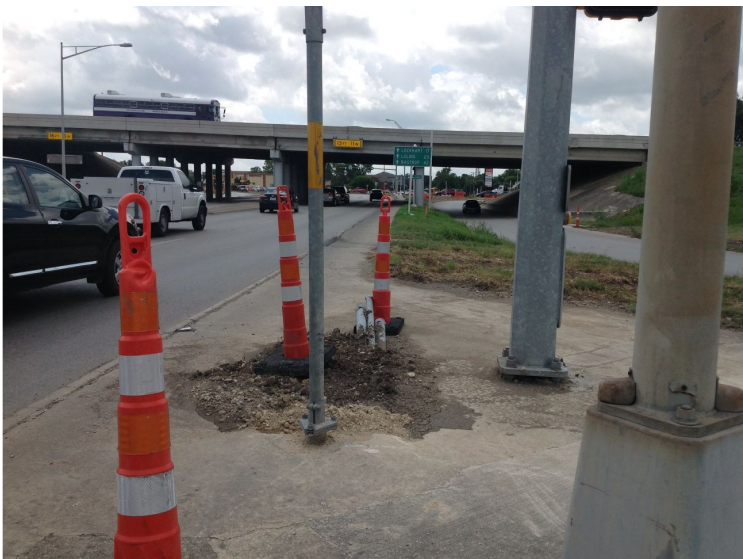
Location Photos

Ramp Elements	Curb ramp provided where an accessible route crosses a barrier:	YES
	Is the slope of the ramp 1:12 or less:	YES
	Transition from curb ramp slope to roadway free from abrupt changes, no greater than 1:20:	NO
	Ramp is at least 36" wide:	YES
	Ramp surface is stable, firm, and slip resistant:	YES
Flare	Flares (if present) are 1:10 or less measured along the curb line; or If landing at top of ramp is not provided flares are 1:12 or less:	YES
Detectable Warning Surface	Curb ramp is located such that it does not project into roadway or parking aisles:	N/A
	Detectable warning is present:	YES
	DWS maintains correct geometric controls; 0.9" diameter domes, 0.2" in height, spaced at 2.35" and visually contracts adjacent ramp surface:	YES
Special Ramps	Ramp maintains defined edges parallel to direction of pedestrian travel; maintains 4'x4' turning pad contained in crosswalk; flared sides 24" segment on each side of ramp within crosswalk lines:	N/A

Ramp is located so they will not be obstructed by parked vehicles:	N/A
	Ramp wholly contained within the crosswalk lines:	YES
	If island is present; Island maintains a cut through at street level or ramps on either side with landing between them:	N/A
