CITY OF SAN MARCOS ADA TRANSITION PLAN SIGNALIZED INTERSECTION ASSESSMENT AND COMPLIANCE REPORT

Location ID: 0000000310
 North-South Cross Street: SBFR IH 35
 East-West Cross Street: TX HWY 80

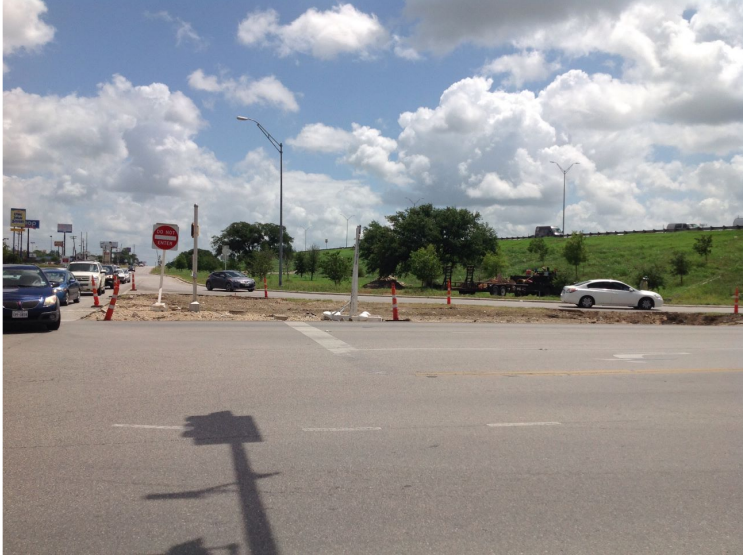
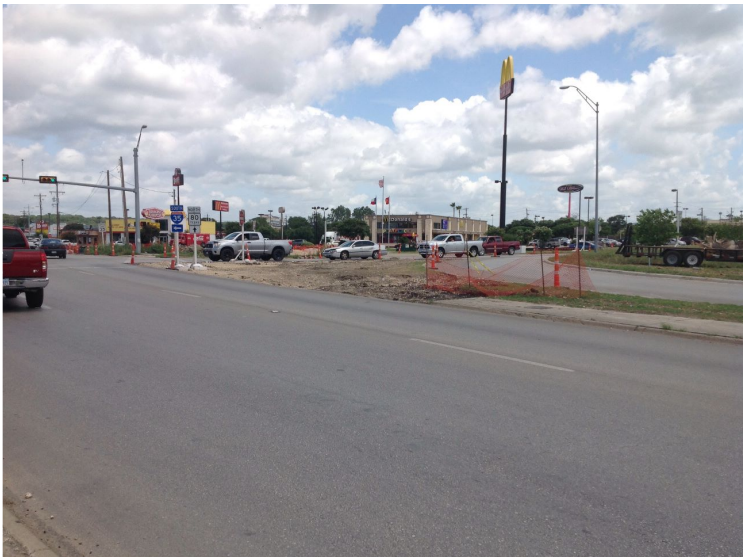
Location Photos

Ramp Elements	Curb ramp provided where an accessible route crosses a barrier:	NO
	Is the slope of the ramp 1:12 or less:	NO
	Transition from curb ramp slope to roadway free from abrupt changes, no greater than 1:20:	NO
	Ramp is at least 36" wide:	NO
	Ramp surface is stable, firm, and slip resistant:	NO
Flare	Flares (if present) are 1:10 or less measured along the curb line; or If landing at top of ramp is not provided flares are 1:12 or less:	NO
Detectable Warning Surface	Curb ramp is located such that it does not project into roadway or parking aisles:	N/A
	Detectable warning is present:	NO
	DWS maintains correct geometric controls; 0.9" diameter domes, 0.2" in height, spaced at 2.35" and visually contracts adjacent ramp surface:	NO
Special Ramps	Ramp maintains defined edges parallel to direction of pedestrian travel; maintains 4'x4' turning pad contained in crosswalk; flared sides 24" segment on each side of ramp within crosswalk lines:	N/A
