Utility Conflict Report

OWNER	Utility	SAWS	Corridor	NOGALITOS	SITE PHOTOS		
	Contact	ANN PECHE	ID	3042			
GENERAL INFO	Utility	WATER

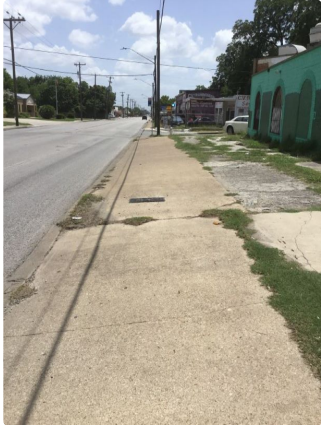
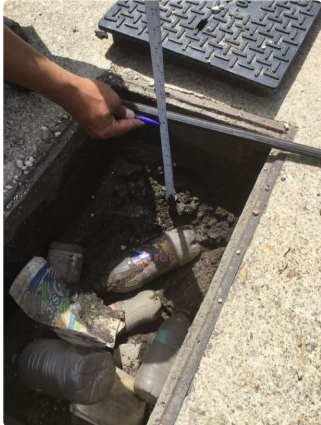
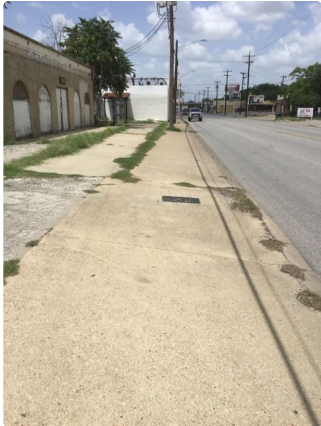
Size and Material	STANDARD WATER METER, STEEL					
	Accessible Route	ASSET IS INSIDE ACCESSIBLE ROUTE					
	Longitudinal or Crossing	CROSSING					
	Placement Relative to ROW	INSIDE ROW					
LOCATION	Sheet No.	125

Comment	Top of meter to surface = 8" Rubber lid thickness = 2" Meter to back of sidewalk = 4'-0 1/2" Sidewalk width = 9'-3" Lower cover 3-4" due to lowering of adjacent sidewalk					
Date Collected		7/10/2018 2:57:24 PM		Date Modified		10/12/2018 3:14:06 PM

Test Hole No	N/A					
	Test Hole Depth	N/A					
RESOLUTION	Recommended Action	MINIMIZE - PROTECT IN PLACE					
	Estimated Resolution Date						
	Resolution Status	UTILITY OWNER INFORMED OF UTILITY
