Utility Conflict Report

OWNER	Utility	SAWS	Corridor	NOGALITOS	SITE PHOTOS		
	Contact	ANN PECHE	ID	3060			
GENERAL INFO	Utility	WATER

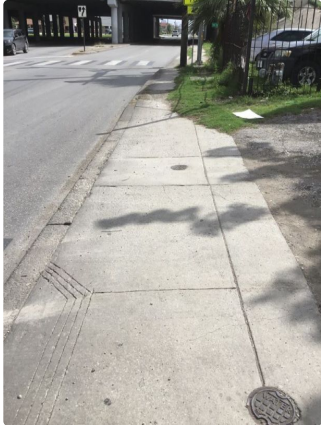
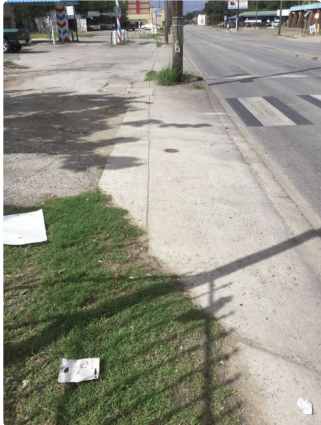
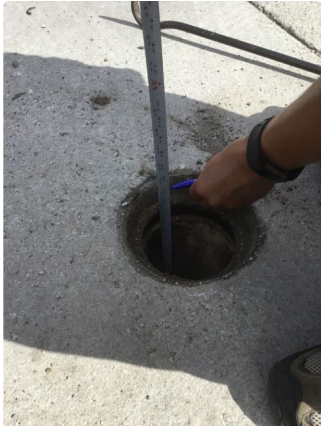
Size and Material	STANDARD WATER VALVE, CAST IRON					
	Accessible Route	ASSET IS INSIDE ACCESSIBLE ROUTE					
	Longitudinal or Crossing	CROSSING					
	Placement Relative to ROW	INSIDE ROW					
LOCATION	Sheet No.	131

Station	143+39.80					
	Offset	20.42					
	Latitude	+29.395596					
	Longitude	-98.51593					
SUE	Level of Investigation Req'd	NONE

Test Hole No	N/A					
	Test Hole Depth	N/A					
RESOLUTION	Recommended Action	MINIMIZE - PROTECT IN PLACE					
	Estimated Resolution Date						
	Resolution Status	UTILITY OWNER INFORMED OF UTILITY					
	Comment	Top of valve to surface = 3'-5" Meter to back of curb = 2'-10 1/2" Sidewalk width = 4'-3" Lid thickness = 5"					
Date Collected		7/11/2018 10:19:41 AM		Date Modified		10/12/2018 3:14:06 PM
