Utility Conflict Report

| OWNER | Utility | CPS | Corridor | SW MILITARY | SITE PHOTOS | | |
| GENERAL INFO | Utility | ELECTRIC | | | | | |
| | Size and Material | STANDARD POWER POLE, TIMBER | | | | | |

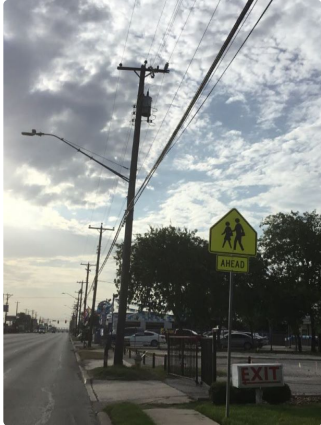
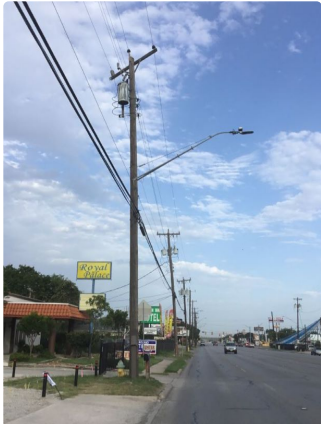
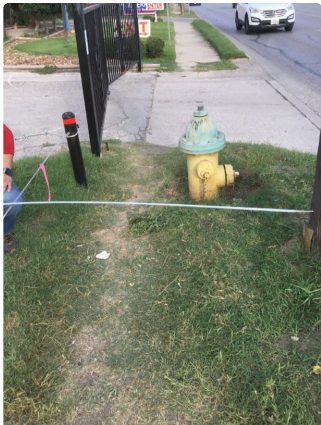
| | Accessible Route | ASSET IS INSIDE ACCESSIBLE ROUTE | | | | | |
| RESOLUTION | Recommended Action | NO CONFLICT | | | | | |
| | Comment | Pole ID: 476612 Pole marking: - 294 Wire fence to pole = 4'-7" Back of curb to pole = 2'-11" Back of curb to mailbox = 1'-9" CATV Cable | | | | | |
