Utility Conflict Report

OWNER	Utility	SAWS	Corridor	SW MILITARY	SITE PHOTOS		
	Contact	ANN PECHE	ID	3106			
GENERAL INFO	Utility	WATER

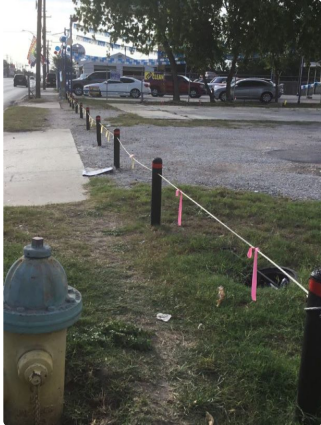
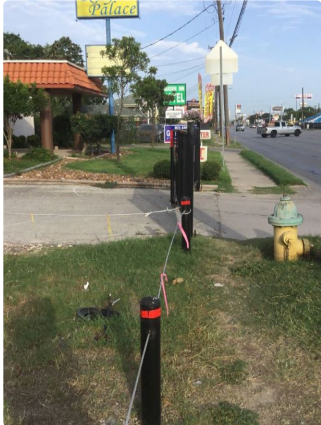
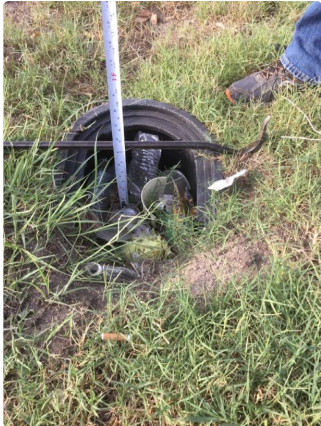
Size and Material	STANDARD WATER METER, STEEL					
	Accessible Route	ASSET IS OUTSIDE ACCESSIBLE ROUTE					
	Longitudinal or Crossing	CROSSING					
	Placement Relative to ROW	INSIDE ROW					
LOCATION	Sheet No.	132

Test Hole No	N/A					
	Test Hole Depth	N/A					
RESOLUTION	Recommended Action	NO CONFLICT					
	Estimated Resolution Date						
	Resolution Status	NO RESOLUTION WAS REQUIRED					
	Comment	Top of meter to surface = 5" Metal wire fence to utility = 8" No lid Trash in the utility box					
Date Collected		7/24/2018 8:23:25 AM		Date Modified		11/28/2018 6:59:12 AM
