Utility Conflict Report

OWNER	Utility	SAWS	Corridor	SW MILITARY	SITE PHOTOS		
	Contact	ANN PECHE	ID	3112			
GENERAL INFO	Utility	WATER

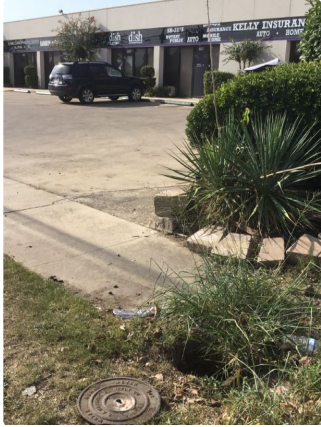
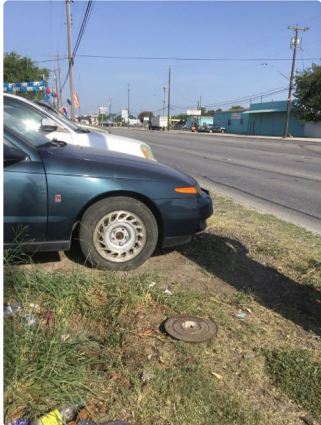
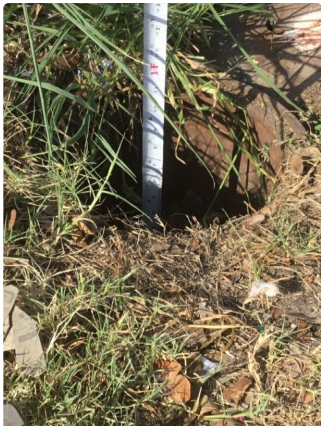
Size and Material	STANDARD WATER METER, STEEL					
	Accessible Route	ASSET IS INSIDE ACCESSIBLE ROUTE					
	Longitudinal or Crossing	CROSSING					
	Placement Relative to ROW	INSIDE ROW					
LOCATION	Sheet No.	132

Test Hole No	N/A					
	Test Hole Depth	N/A					
RESOLUTION	Recommended Action	MINIMIZE - PROTECT IN PLACE					
	Estimated Resolution Date						
	Resolution Status	UTILITY OWNER INFORMED OF UTILITY					
	Comment	Back of curb to meter = 8'-4" Top of meter to surface = 10" Lid thickness = 3/8" Broken lid					
Date Collected		7/24/2018 9:26:50 AM		Date Modified		11/28/2018 6:59:12 AM
