Utility Conflict Report

OWNER	Utility	SAWS	Corridor	SW MILITARY	SITE PHOTOS		
	Contact	ANN PECHE	ID	3116			
GENERAL INFO	Utility	SANITARY SEWER

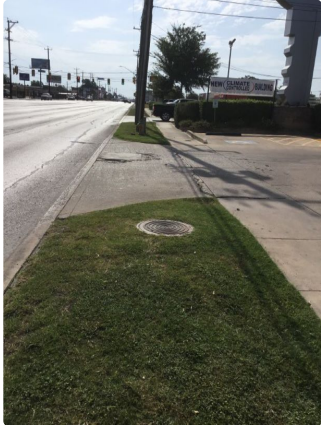
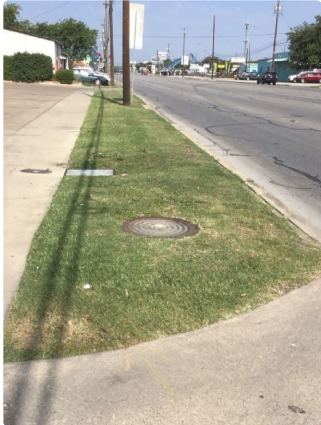
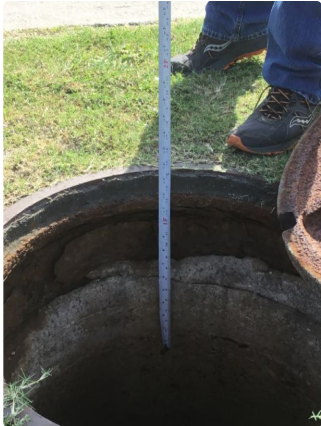
Size and Material	STANDARD MANHOLE, CAST IRON					
	Accessible Route	ASSET IS OUTSIDE ACCESSIBLE ROUTE					
	Longitudinal or Crossing	CROSSING					
	Placement Relative to ROW	INSIDE ROW					
LOCATION	Sheet No.	134

Station	546+47.13					
	Offset	17.0001					
	Latitude	+29.357751					
	Longitude	-98.55520					
SUE	Level of Investigation Req'd	NONE

Test Hole No	N/A					
	Test Hole Depth	N/A					
RESOLUTION	Recommended Action	NO CONFLICT					
	Estimated Resolution Date						
	Resolution Status	NO RESOLUTION WAS REQUIRED					
	Comment	Front of sidewalk to manhole = 2'-3" Sidewalk width = 4'-5" Bottom of cone to surface = 1'-3 1/2" Lid thickness = 1 5/8"					
Date Collected		7/24/2018 9:57:55 AM		Date Modified		11/28/2018 6:59:12 AM
