Utility Conflict Report

OWNER	Utility	CPS	Corridor	NOGALITOS	SITE PHOTOS		
	Contact	JAKE MARTINEZ	ID	4056			
GENERAL INFO	Utility	ELECTRIC					
	Size and Material	STANDARD POWER POLE, TIMBER					
	Accessible Route	ASSET IS INSIDE ACCESSIBLE ROUTE					
	Longitudinal or Crossing	CROSSING					
	Placement Relative to ROW	INSIDE ROW					
LOCATION	Sheet No.	79					
	Station	123+06.34					
	Offset	22.93					
	Latitude	+29.391093					
	Longitude	-98.51973					
SUE	Level of Investigation Req'd	NONE					
	Test Hole No	N/A					
	Test Hole Depth	N/A					
RESOLUTION	Recommended Action	MINIMIZE - PROTECT IN PLACE					
	Estimated Resolution Date						
	Resolution Status	UTILITY OWNER INFORMED OF UTILITY

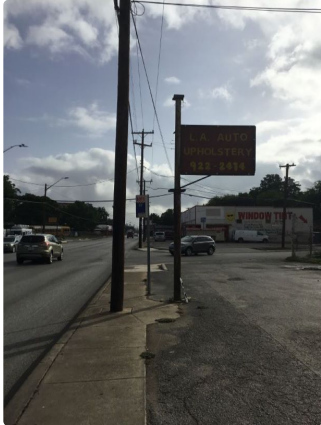
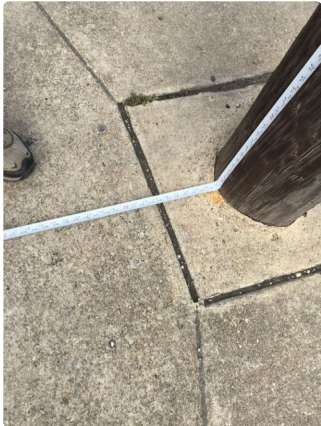
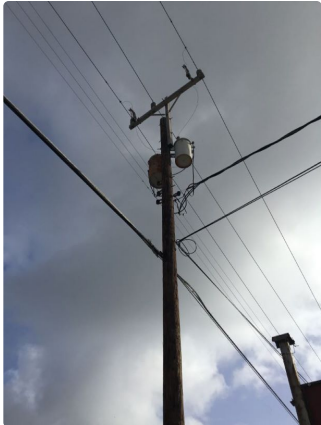
Comment	Pole to back of sidewalk = 3'-11" Pole to back of curb = 1'-6" Width of sidewalk (at pole) = 6'-3" Width of sidewalk (typical) = 4'-0" Adjacent to VIA bus stop no. 61896 CATV cable					
Date Collected		7/10/2018 8:48:40 AM		Date Modified		9/13/2018 2:01:27 PM
