Utility Conflict Report

OWNER	Utility	CPS	Corridor	SW MILITARY	SITE PHOTOS	
	Contact	JAKE MARTINEZ	ID	4090		
GENERAL INFO	Utility	ELECTRIC

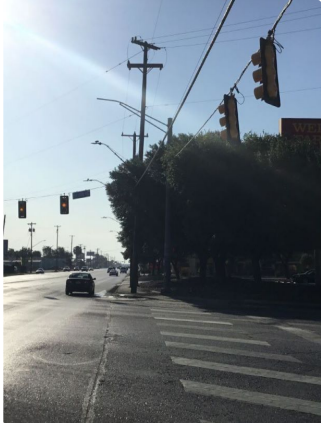
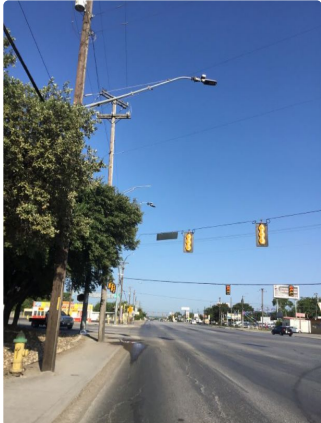
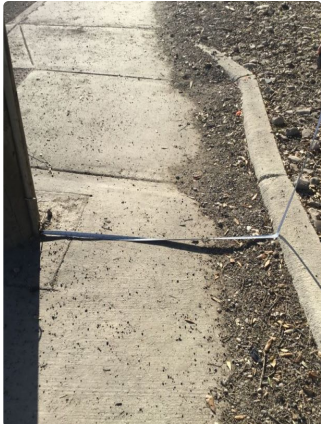
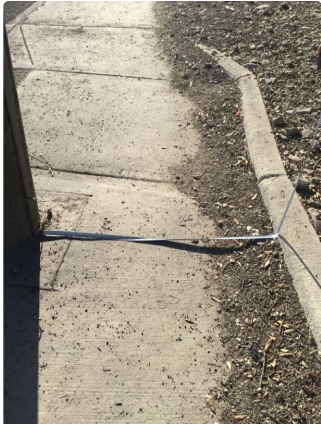
Size and Material	STANDARD POWER POLE, TIMBER				
	Accessible Route	ASSET IS INSIDE ACCESSIBLE ROUTE				
	Longitudinal or Crossing	CROSSING				
	Placement Relative to ROW	INSIDE ROW				
LOCATION	Sheet No.

Station	533+39.02				
	Offset	16.4986				
	Latitude	+29.358156				
	Longitude	-98.55932				
SUE	Level of Investigation Req'd	NONE

Estimated Resolution Date	8/14/2018				
	Resolution Status	NO RESOLUTION WAS REQUIRED				
	Comment	Pole ID: LW 55709; 500149 Back of curb to pole = 3'-2" Face of wall to pole = 3'-9" Sidewalk width = 8'-4" Pole diameter = 14" CATV cable				
Date Collected		7/23/2018 8:39:59 AM		Date Modified	11/28/2018 6:59:12 AM

Test Hole No	N/A				
	Test Hole Depth	N/A				
RESOLUTION	Recommended Action	NO CONFLICT
