Utility Conflict Report

OWNER	Utility	SAWS	Corridor	SW MILITARY	SITE PHOTOS

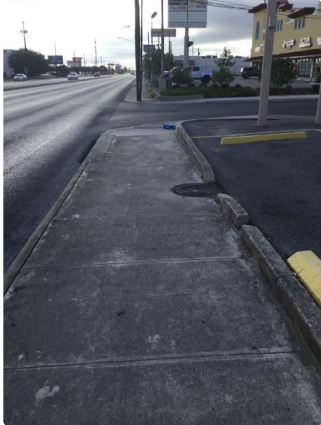
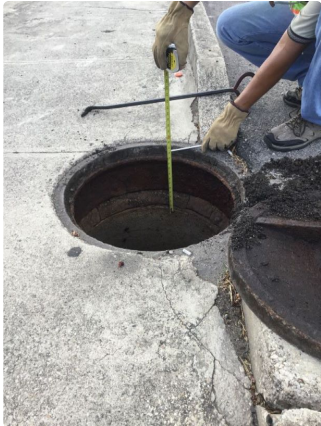
Contact	ANN PECHE	ID	4183	
GENERAL INFO	Utility	SANITARY SEWER			
	Size and Material	STANDARD MANHOLE, CAST IRON			
	Accessible Route	ASSET IS INSIDE ACCESSIBLE ROUTE			
	Longitudinal or Crossing	CROSSING			
	Placement Relative to ROW	INSIDE ROW			
LOCATION	Sheet No.	160			
	Station	698+36.94			
	Offset	18.9002			
	Latitude	+29.356576			
	Longitude	-98.50762			
SUE	Level of Investigation Req'd	NONE			
	Test Hole No	N/A			
	Test Hole Depth	N/A			
RESOLUTION	Recommended Action	MINIMIZE - PROTECT IN PLACE

Estimated Resolution Date				
	Resolution Status	UTILITY OWNER INFORMED OF UTILITY			
	Comment	Top of cone to surface = 1'-1 1/2" Lid thickness = 1 1/2" Manhole to back of curb = 4'-9" Sidewalk width = 6'-6"			
Date Collected		8/6/2018 8:46:57 AM		Date Modified	12/17/2018 3:06:04 PM
