Utility Conflict Report

OWNER	Utility	CPS	Corridor	SW MILITARY	SITE PHOTOS	
	Contact	JAKE MARTINEZ	ID	4224		
GENERAL INFO	Utility	ELECTRIC

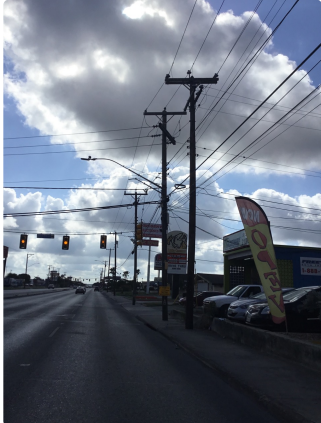
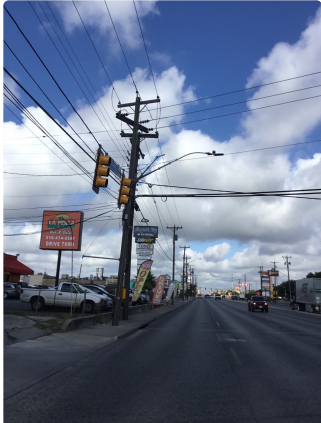
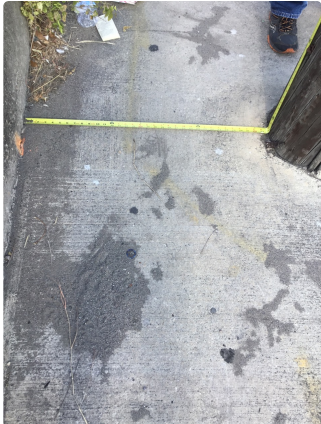
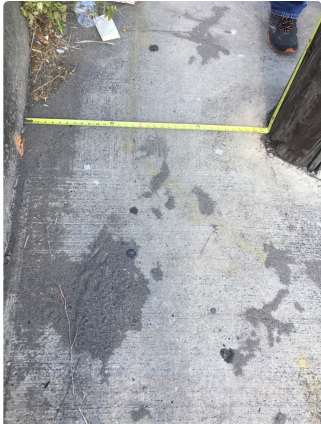
Size and Material	STANDARD POWER POLE, TIMBER				
	Accessible Route	ASSET IS INSIDE ACCESSIBLE ROUTE				
	Longitudinal or Crossing	CROSSING				
	Placement Relative to ROW	INSIDE ROW				
LOCATION	Sheet No.	168

Station	725+26.98				
	Offset	13.97				
	Latitude	+29.356622				
	Longitude	-98.49922				
SUE	Level of Investigation Req'd	NONE

Estimated Resolution Date	11/21/2018				
	Resolution Status	NO RESOLUTION WAS REQUIRED				
	Comment	Pole ID: LW 46806; 380655 Back of curb to pole = 2'-4" Back of sidewalk to pole = 2'-10" Sidewalk width = 6'-1.5"				
Date Collected		8/7/2018 9:52:34 AM		Date Modified	11/28/2018 6:59:12 AM

Test Hole No	N/A				
	Test Hole Depth	N/A				
RESOLUTION	Recommended Action	NO CONFLICT
