## Utility Conflict Report

<b>OWNER</b>	<b>Utility</b>	AT&T	<b>Corridor</b>	SW MILITARY	<b>SITE PHOTOS</b>	
	<b>Contact</b>	PHILIP AUSTIN	<b>ID</b>	7027		
<b>GENERAL INFO</b>	<b>Utility</b>	COMMUNICATIONS

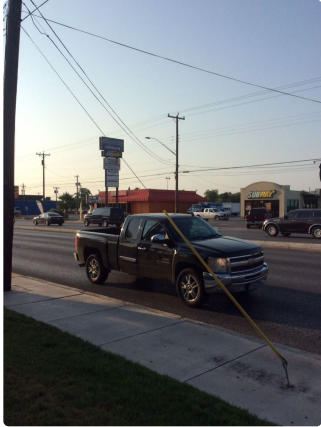
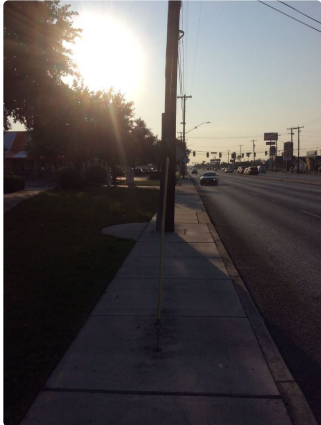
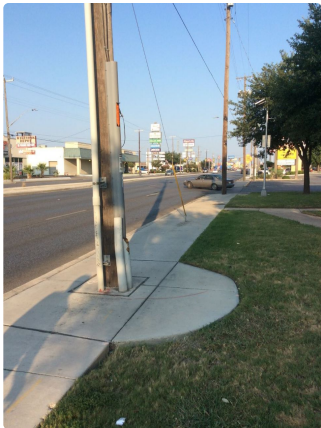
<b>Size and Material</b>	1/2" CABLE, STEEL				
	<b>Accessible Route</b>	ASSET IS INSIDE ACCESSIBLE ROUTE				
	<b>Longitudinal or Crossing</b>	CROSSING				
	<b>Placement Relative to ROW</b>	INSIDE ROW

<b>Test Hole No</b>	N/A				
	<b>Test Hole Depth</b>	N/A				
<b>RESOLUTION</b>	<b>Recommended Action</b>	ACCOMODATE - RELOCATION				
	<b>Estimated Resolution Date</b>	12/18/2018				
	<b>Resolution Status</b>	UTILITY OWNER INFORMED OF UTILITY				
	<b>Comment</b>	Pole ID: 408155 Guy wire vertical clearance not sufficient Convert to sidewalk guy
