Utility Conflict Report

OWNER	Utility	CPS	Corridor	SW MILITARY	SITE PHOTOS	
	Contact	JAKE MARTINEZ	ID	7029		
GENERAL INFO	Utility	ELECTRIC

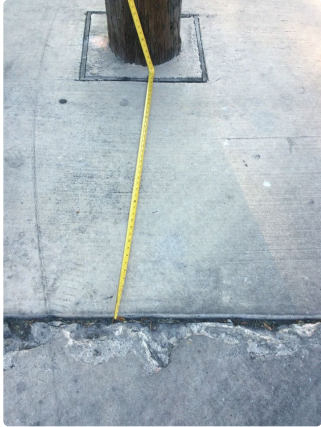
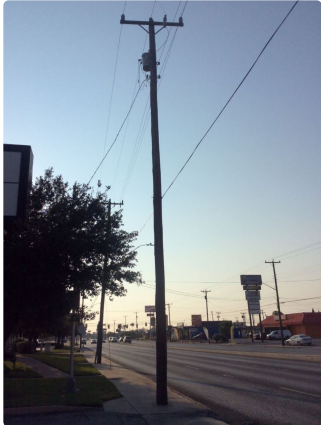
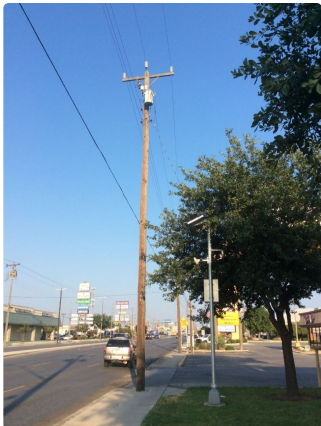
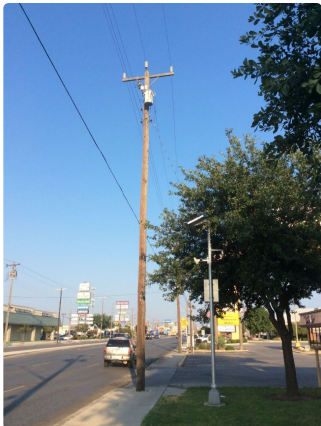
Size and Material	STANDARD POWER POLE, TIMBER				
	Accessible Route	ASSET IS INSIDE ACCESSIBLE ROUTE				
	Longitudinal or Crossing	CROSSING				
	Placement Relative to ROW	INSIDE ROW				
LOCATION	Sheet No.	212

Station	951+52.30				
	Offset	-17.5247				
	Latitude	+29.356874				
	Longitude	-98.50038				
SUE	Level of Investigation Req'd	NONE

Estimated Resolution Date					
	Resolution Status	NO RESOLUTION WAS REQUIRED				
	Comment	Pole ID: 408156 Back of curb to pole = 2'-7" Pole to driveway = 3'-7"				
Date Collected		8/3/2018 8:15:07 AM		Date Modified	11/28/2018 6:59:12 AM

Test Hole No	N/A				
	Test Hole Depth	N/A				
RESOLUTION	Recommended Action	NO CONFLICT
