Utility Conflict Report

OWNER	Utility	SAWS	Corridor	SW MILITARY	SITE PHOTOS	
	Contact	ANN PECHE	ID	7080		
GENERAL INFO	Utility	WATER

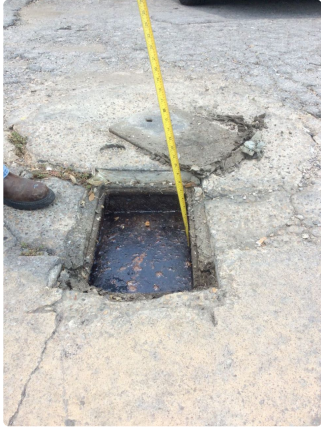
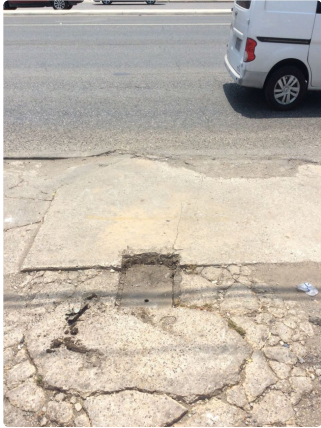
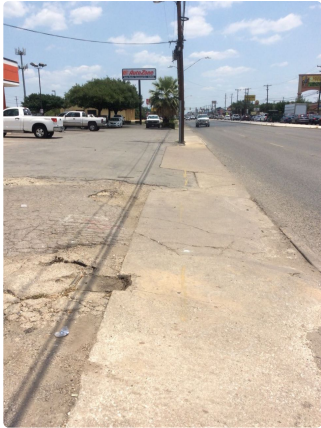
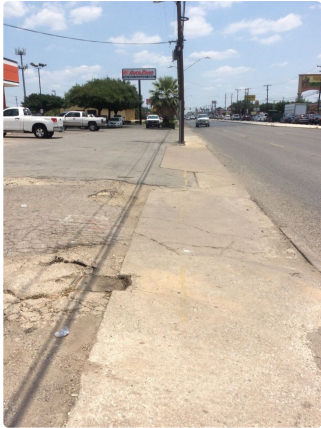
Size and Material	STANDARD WATER METER, STEEL				
	Accessible Route	ASSET IS OUTSIDE ACCESSIBLE ROUTE				
	Longitudinal or Crossing	CROSSING				
	Placement Relative to ROW	INSIDE ROW				
LOCATION	Sheet No.	201

Estimated Resolution Date					
	Resolution Status	NO RESOLUTION WAS REQUIRED				
	Comment	Meter filled with water Top of water to surface = 2" Meter adjacent to edge of driveway apron				
Date Collected		8/3/2018 1:38:31 PM		Date Modified	11/28/2018 6:59:12 AM

Test Hole No	N/A				
	Test Hole Depth	N/A				
RESOLUTION	Recommended Action	NO CONFLICT
