Utility Conflict Report

OWNER	Utility	SAWS	Corridor	SW MILITARY	SITE PHOTOS	
	Contact	ANN PECHE	ID	7082		
GENERAL INFO	Utility	WATER

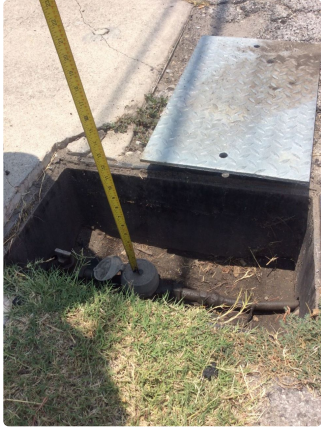
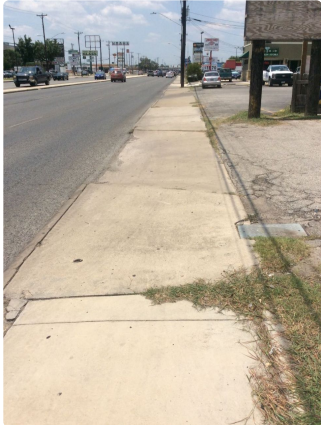
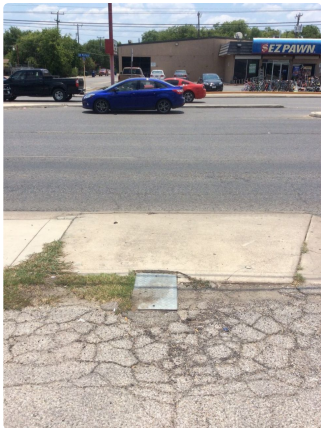
Size and Material	STANDARD WATER METER, STEEL				
	Accessible Route	ASSET IS INSIDE ACCESSIBLE ROUTE				
	Longitudinal or Crossing	CROSSING				
	Placement Relative to ROW	INSIDE ROW				
LOCATION	Sheet No.	201

Test Hole No	N/A				
	Test Hole Depth	N/A				
RESOLUTION	Recommended Action	MINIMIZE - PROTECT IN PLACE				
	Estimated Resolution Date					
	Resolution Status	UTILITY OWNER INFORMED OF UTILITY				
	Comment	Meter adjacent to back of sidewalk Top of meter to surface = 7"				
Date Collected		8/3/2018 1:48:27 PM		Date Modified	12/18/2018 7:59:02 AM
