Utility Conflict Report

OWNER	Utility	SAWS	Corridor	SW MILITARY	SITE PHOTOS		
	Contact	ANN PECHE	ID	7115			
GENERAL INFO	Utility	WATER

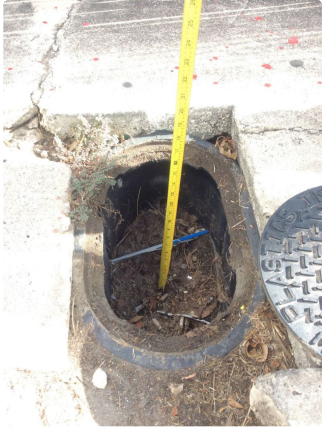
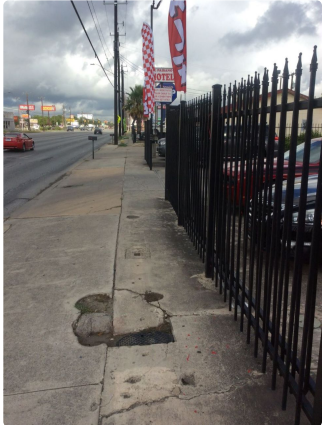
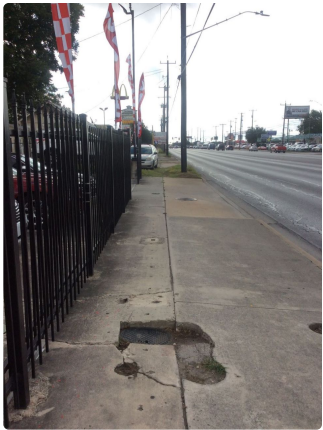
Size and Material	STANDARD WATER METER, STEEL					
	Accessible Route	ASSET IS INSIDE ACCESSIBLE ROUTE					
	Longitudinal or Crossing	CROSSING					
	Placement Relative to ROW	INSIDE ROW					
LOCATION	Sheet No.	188

Station	788+02.18					
	Offset	-21.13					
	Latitude	+29.357687					
	Longitude	-98.55148					
SUE	Level of Investigation Req'd	NONE

Test Hole No	N/A					
	Test Hole Depth	N/A					
RESOLUTION	Recommended Action	MINIMIZE - PROTECT IN PLACE					
	Estimated Resolution Date						
	Resolution Status	UTILITY OWNER INFORMED OF UTILITY					
	Comment	Fence to meter = 1'-8" Top of meter to surface = 11" Rubber lid					
Date Collected		8/6/2018 9:26:52 AM		Date Modified		11/28/2018 6:59:12 AM
