Utility Conflict Report

OWNER	Utility	CPS	Corridor	NOGALITOS	SITE PHOTOS		
	Contact	JAKE MARTINEZ	ID	3032			
GENERAL INFO	Utility	ELECTRIC

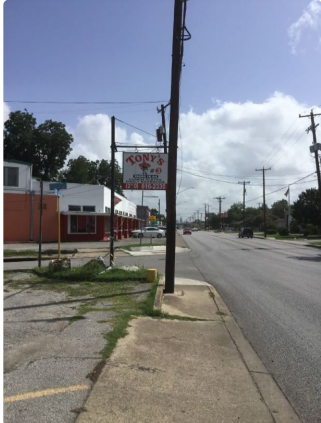
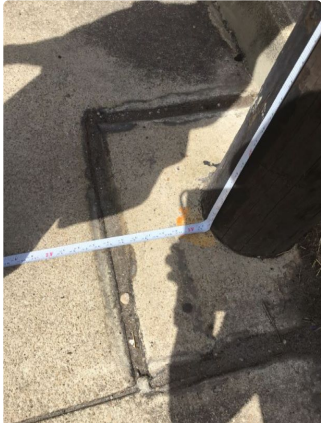
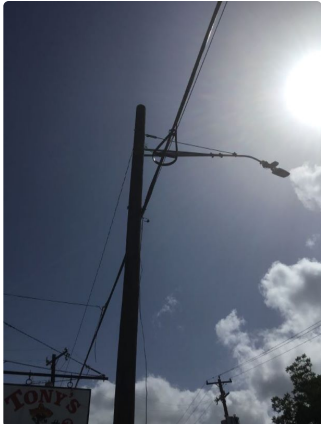
Size and Material	STANDARD POWER POLE, TIMBER					
	Accessible Route	ASSET IS INSIDE ACCESSIBLE ROUTE					
	Longitudinal or Crossing	CROSSING					
	Placement Relative to ROW	INSIDE ROW					
LOCATION	Sheet No.	82

Test Hole No	N/A					
	Test Hole Depth	N/A					
RESOLUTION	Recommended Action	MINIMIZE - PROTECT IN PLACE					
	Estimated Resolution Date						
	Resolution Status	UTILITY OWNER INFORMED OF UTILITY					
	Comment	Pole ID: LW 57272; PL 386750 Pole to back of curb = 3'-2" Pole to face of wall = 2"					
Date Collected		7/10/2018 10:47:59 AM		Date Modified		9/13/2018 2:01:20 PM
