Utility Conflict Report

OWNER	Utility	CPS	Corridor	NOGALITOS	SITE PHOTOS		
	Contact	JAKE MARTINEZ	ID	4009			
GENERAL INFO	Utility	ELECTRIC

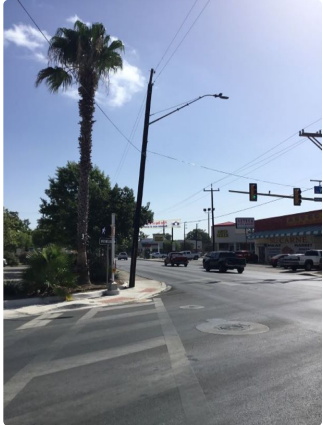
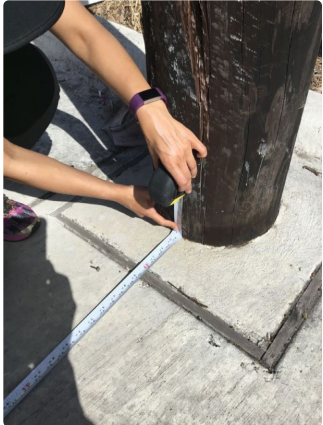
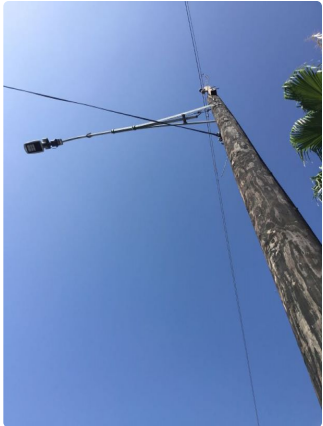
Size and Material	STANDARD POWER POLE, TIMBER					
	Accessible Route	ASSET IS INSIDE ACCESSIBLE ROUTE					
	Longitudinal or Crossing	CROSSING					
	Placement Relative to ROW	INSIDE ROW					
LOCATION	Sheet No.

Station	104+90.26					
	Offset	-27.5037					
	Latitude	+29.387288					
	Longitude	-98.52336					
SUE	Level of Investigation Req'd	NONE

Test Hole No	N/A					
	Test Hole Depth	N/A					
RESOLUTION	Recommended Action	NO CONFLICT					
	Estimated Resolution Date	8/13/2018					
	Resolution Status	NO RESOLUTION WAS REQUIRED					
	Comment	Pole ID: LW52103 & 431483 Pole to back of curb = 4'-4"					
Date Collected		7/2/2018 10:09:39 AM		Date Modified		8/14/2018 4:38:26 PM
