**PUBLIC LIBRARY  
700 E. Common Street  
New Braunfels, TX 78130**

## **ADA SELF-EVALUATION FACILITY SURVEY**

# New Braunfels Public Library

Jun 29, 2021

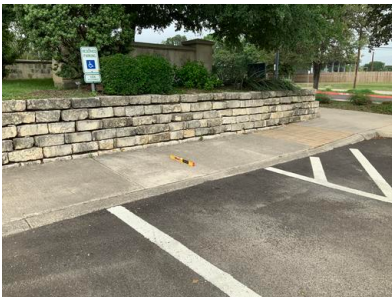
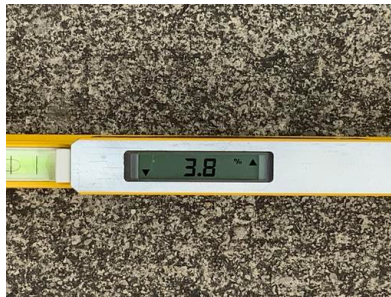
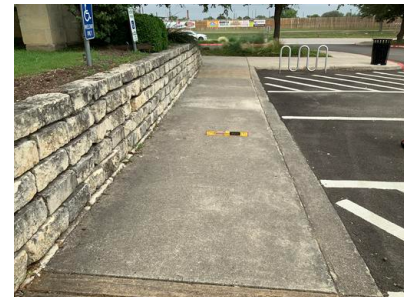
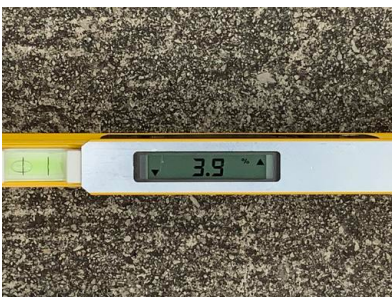
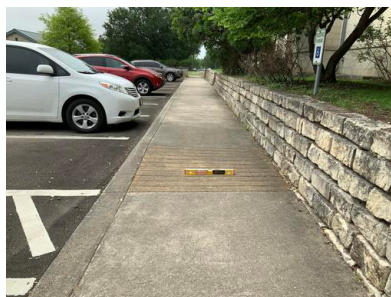
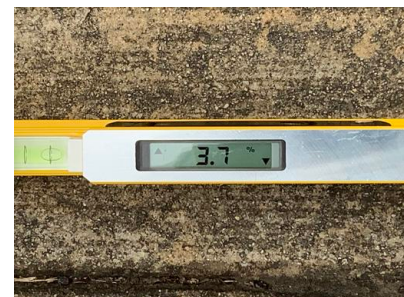
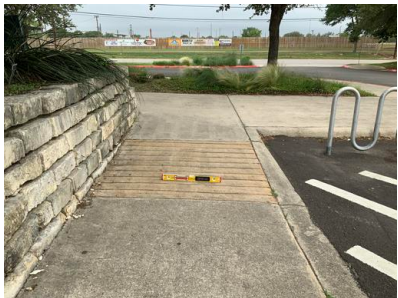
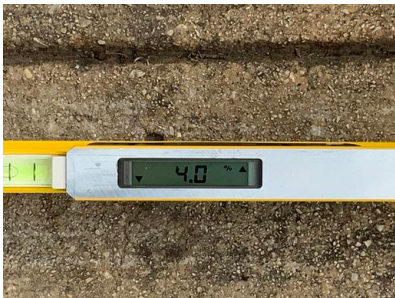
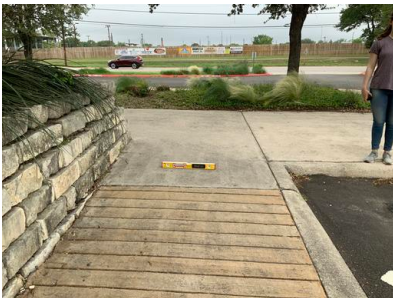
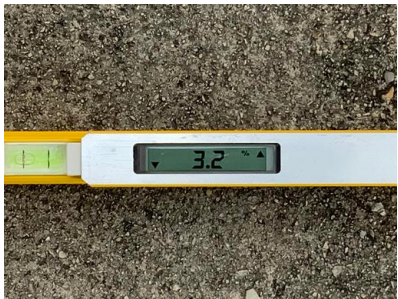
## #6 Priority 1: Curb Ramps

East Parking Lot

The landing and both runs of the parallel curb ramp have a cross slope ranging from 3.2% to 4%.

Recommendation: Remove and replace curb ramp.

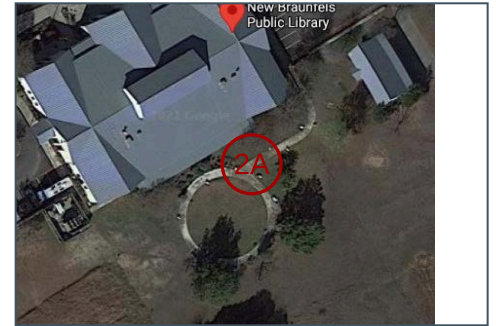
C1

Sidewalk has a 1/2" abrupt change in level between panels.

Recommendation: Grind edge to a maximum 1:2 bevel.

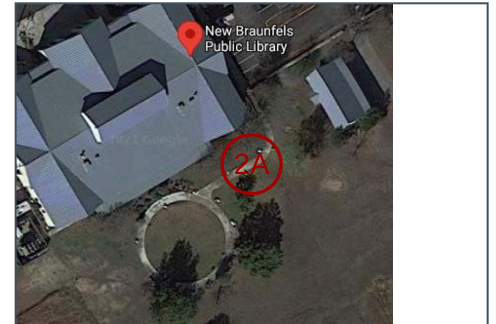
C1

Sidewalk has a cross slope of up to 2.7%.

Recommendation: Remove and replace sidewalk. (3 panels, 168 SF)

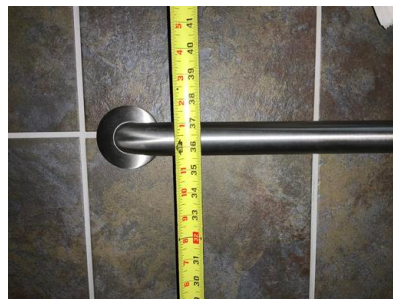
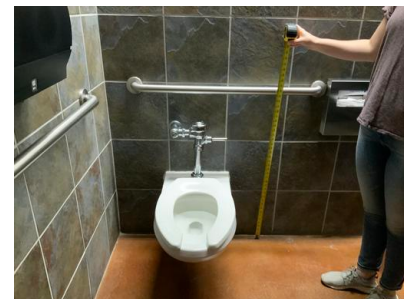
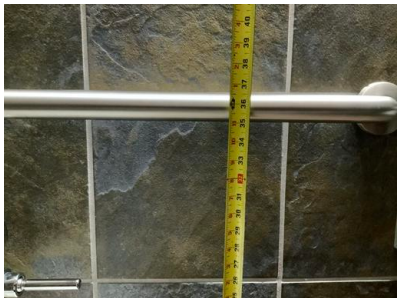
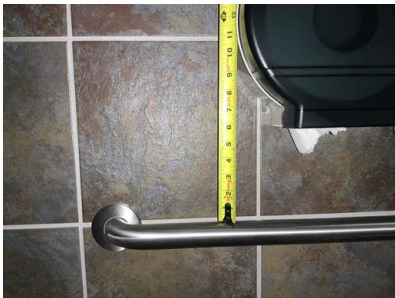
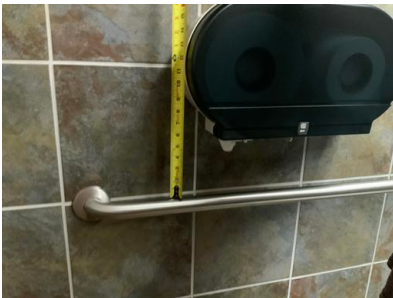
(Note: If these elements were installed prior to March 15, 2012, this condition may enjoy safe harbor until replaced.)

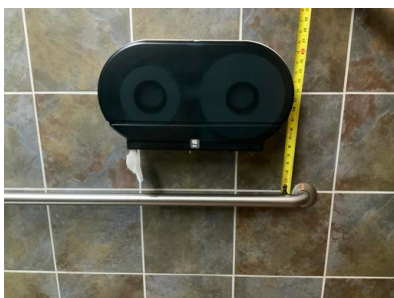
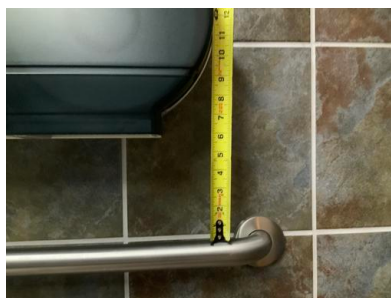
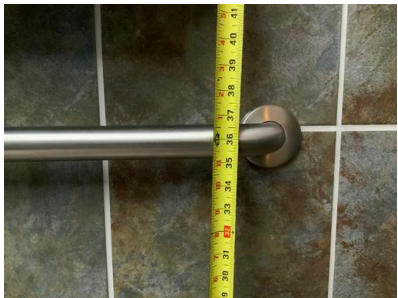
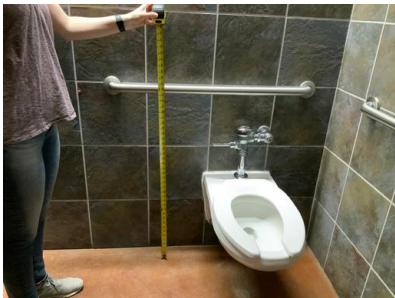
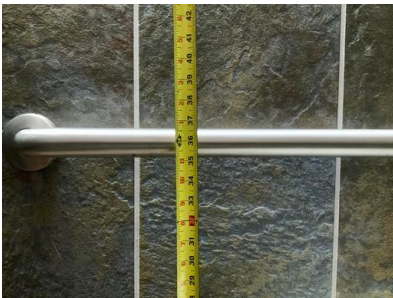
(Note: If these elements were installed prior to March 15, 2012, this condition may enjoy safe harbor until replaced.)

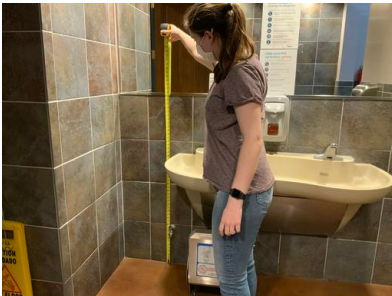
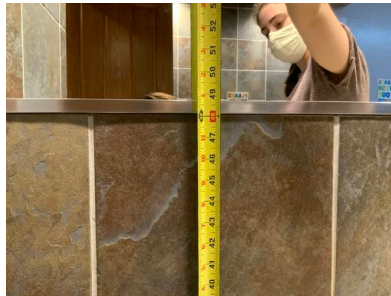
**Sheet**  
A1

## #33 Priority 3: Mirrors

Recommendation: Install a mirror with the bottom of the reflective surface 40" high maximum.

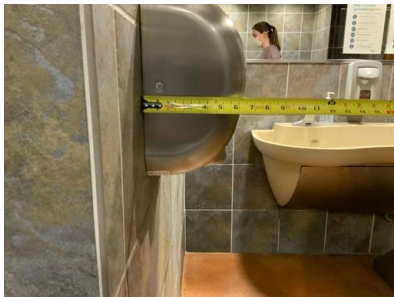
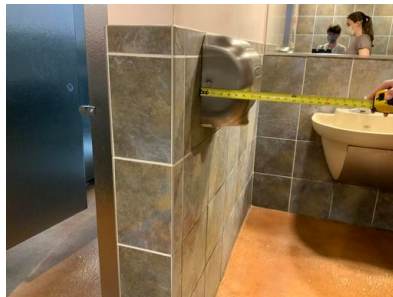
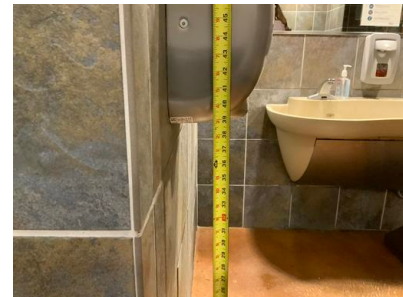
A1

## #27 Priority 3: Protruding Objects

Recommendation: Relocate hand dryer.

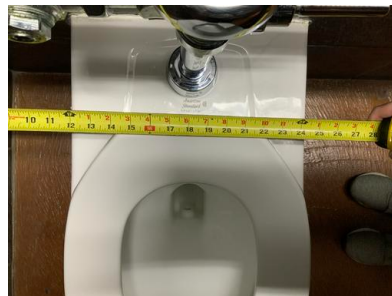
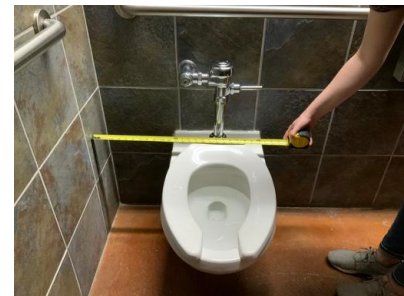
A1

## #29 Priority 3: Water Closets

(Note: If the water closet was installed prior to March 15, 2012, it may enjoy safe harbor until replaced.)

### Recommendation:
